# Learning the lessons from systemic building failures

This review was written by Keith Ross, BRE.

© NHBC Foundation  
NF10  
Published by IHS BRE Press on behalf of NHBC Foundation  
September 2008  
ISBN 978-1-84806-046-3

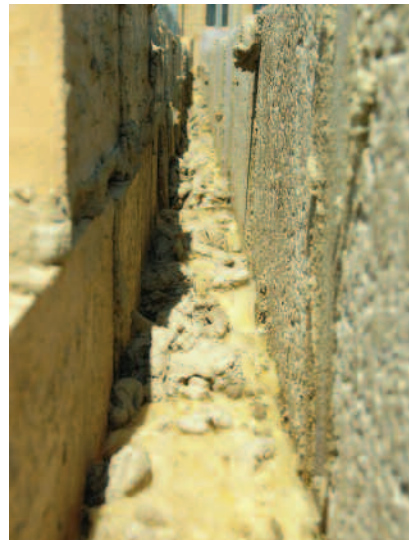
**Figure 3b** Debris in the cavity such as mortar droppings can form a path for water to track across the cavity.

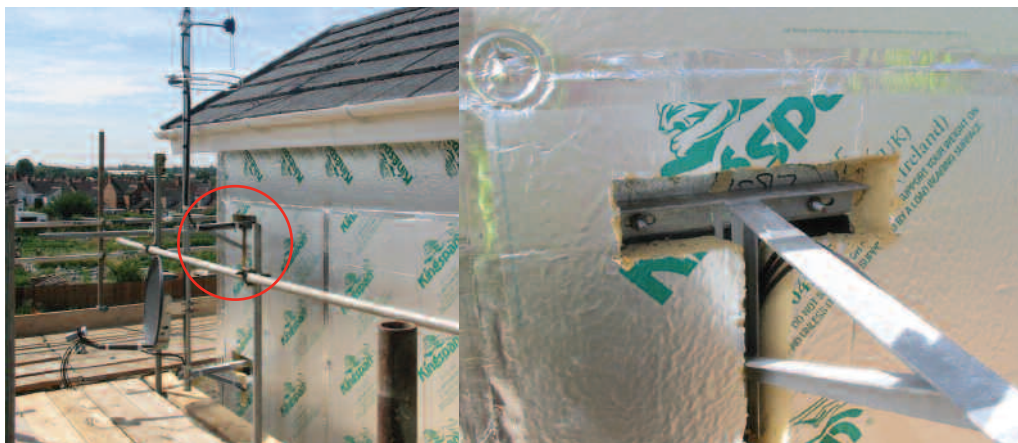
Penetrations through claddings can be difficult to seal properly. Figure 4 shows the attachment of a substantial bracket for a mast to carry aerials and a satellite dish. It will be difficult to get an effective seal around the bracket where it passes through the cladding (in this case a boarded finish is to be used). Surface tension will encourage rainwater to track down the lower diagonal brace, potentially allowing water to penetrate the structure. A more robust solution would be to redesign the bracket so that the diagonal brace slopes downwards away from the building. Alternatively, fixing blocks could be installed behind the cladding so that the bracket could be fixed on the face of the cladding.

**Figure 4** The bracket for aerials and satellite dishes has a lower brace that will encourage water to track towards the building.

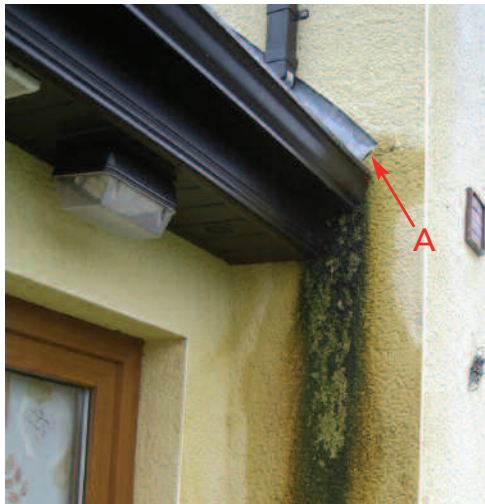
Figure 5 shows a roof abutting a wall where the detailing cannot manage rainwater effectively. The problem is due partly to poor design and installation of the rainwater goods, but the design of the flashing detail is also poor. At 'A' a piece of render stop bead has been applied at the end of the flashing. This point will be vulnerable to the entry of water behind the rendering. A 'kick-out' or 'diverter' flashing to deflect water directly into the gutter would have been better.

**Figure 5** Poor detailing at junction.

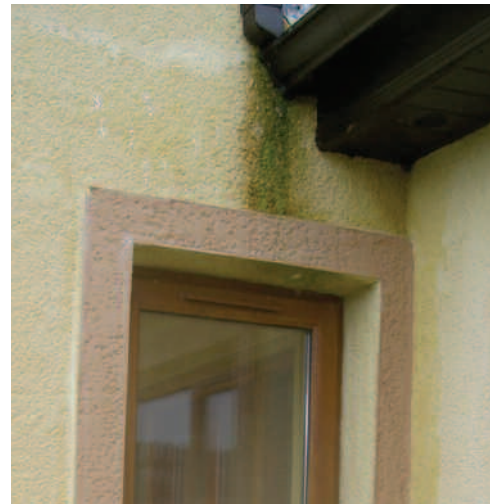
Figure 6 shows a raised architectural feature around a window on the same development. The green stain above is again the result of water over-topping a faulty gutter. It is interesting to note that the stain stops when it meets the raised render but is visible on the soffit immediately above the window. This indicates that some water may be passing behind the raised render.

**Figure 6** Water has penetrated behind the raised decorative feature.

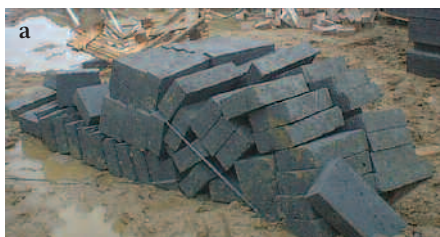
**Figure 7a** Poorly stored blocks become saturated with water in bad weather.

Perhaps the most obvious action that should be taken is to protect materials and components during transit and storage. Many materials, such as bricks and blocks, are often shrink wrapped by the manufacturer. This protection should be left in place as long as possible prior to use. If materials are unprotected when delivered then protection should be provided to prevent materials becoming saturated with rainwater. Figure 7a shows poorly stored blocks on site. The blocks are totally unprotected, allowing them to absorb large amounts of moisture which can lead to a number of adverse effects:

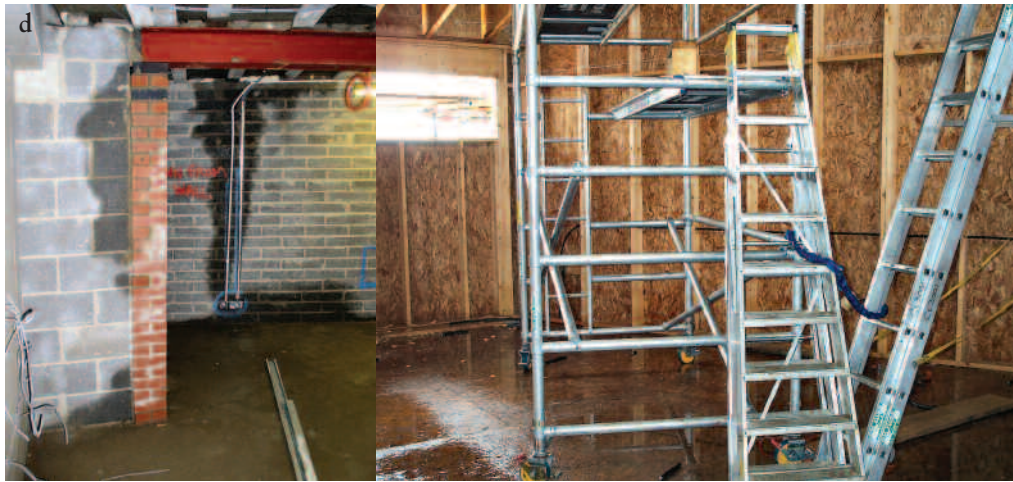
**Figure 7d** Structures becoming wet during construction.

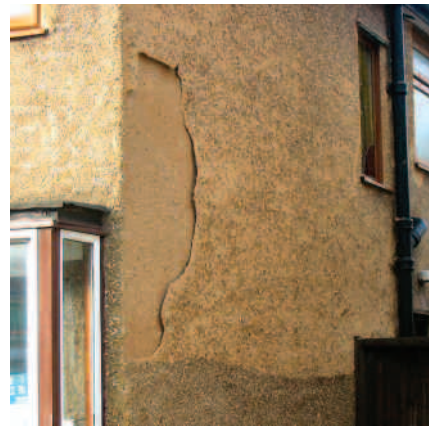
Render has been used for decades as an effective way of reducing rain penetration in areas exposed to severe weather. However, a poorly designed render system can result in serious problems for masonry walls, especially those of solid construction. Figure 8 shows a detached final coat of render that will encourage rain penetration and represents a hazard to people passing by. The render mix incorporated a 'soft' building sand rather than a well-graded sand.

**Figure 8** Poorly specified render with detaching final coat.

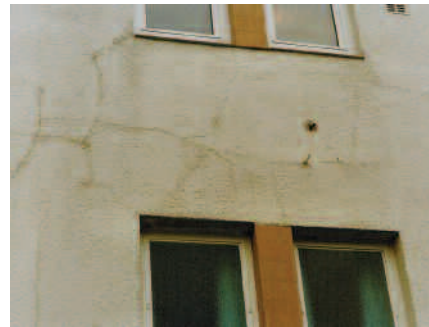
Strong renders tend to shrink and crack on curing, as illustrated in Figure 9. If a strong render is applied to a relatively weak background it will detach, allowing water to penetrate behind the render – see Figure 10. Because the render is dense and impervious the rate of drying is very slow, leading to a number of problems with the fabric:

**Figure 9** Cracking in render typical of a strong mix.

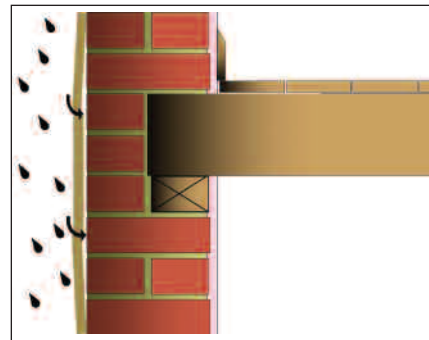
**Figure 10** Cracks allow moisture to accumulate in the walls, which can lead to rotting of embedded timbers.

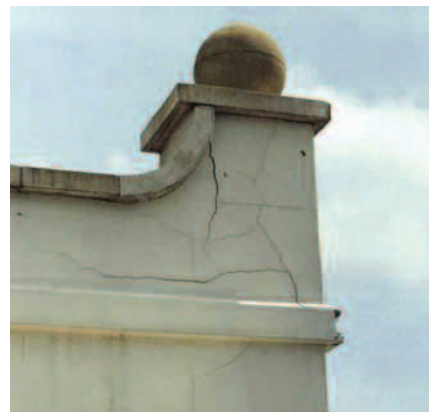
- In solid masonry construction, embedded timbers such as wall plates and the ends of joists that bear on them suffer from decay
- In cavity masonry, corrosion of wall ties can lead to structural problems
- Penetrating damp leads to damage to internal decorative finishes and to mould growth, potentially with associated health problems for occupants in severe cases
- With some bricks bedded in cement mortar, sulfate attack can occur if the masonry is kept damp for prolonged periods. The interaction of sulfates with the cement mortar causes the mortar joint to expand, further opening up cracks as in Figure 11. In severe cases structural problems can ensue.

**Figure 11** Example of sulfate attack on cement render on a parapet.

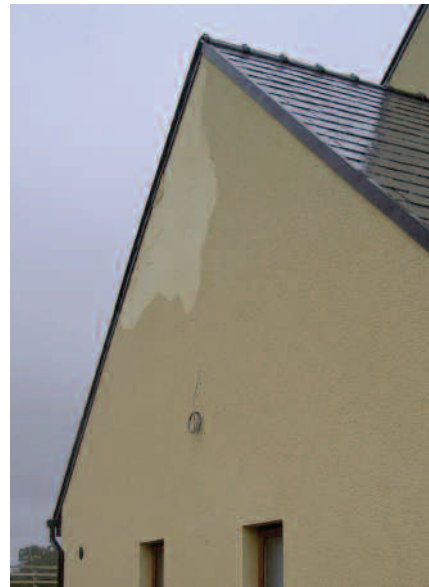
Figure 12 shows bond failure of a polymer render system. Although the operatives who applied the render were competent with conventional render systems, they were not familiar with, or trained to apply, the polymer render. Figure 13 shows cracking in newly applied render over expanded polystyrene used as external insulation. Investigation revealed several poor workmanship issues including an inadequate thickness of base coat and missing reinforcement.

Figure 12 Polymer render failure.

These two examples illustrate the importance of proper training in the application of polymer renders.

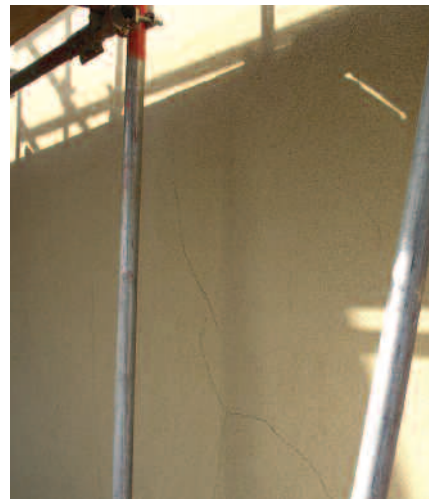
Figure 13 Cracking in newly applied polymer render.

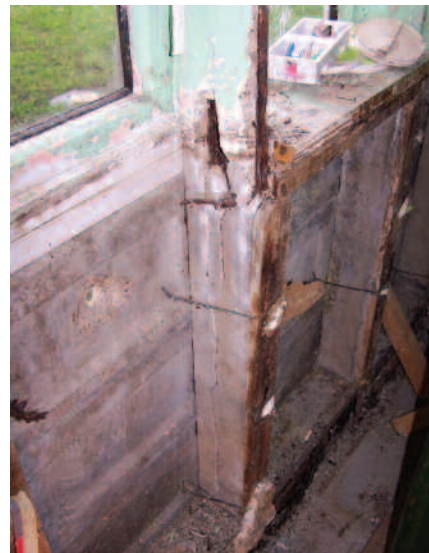
In the early 1980s inspection of an Airey house revealed cracking to the structural PRC columns. Figure 15 shows a recent image of cracking to a PRC column in an Airey house.

Subsequent investigations of other PRC dwelling types revealed similar problems. The cause of the deterioration was found to be corrosion of steel reinforcement, resulting in cracking of the concrete. The rate of deterioration varied widely both between and within different house types. Factors that affected the rate of deterioration were:

**Figure 15** Cracking to PRC column in Airey house.

As a result of the investigations mentioned above, and other subsequent research, the factors that affect concrete durability are now much better understood. Tests have been developed to identify problem aggregates, factors (such as water : cement ratio; compaction; and aggregate type) that determine the quality of concrete have been identified and appropriate guidance documented, and the importance of good cover (50 mm) to steel reinforcement is now well known. Where 50 mm cover is not practical, stainless steel reinforcements can be specified.

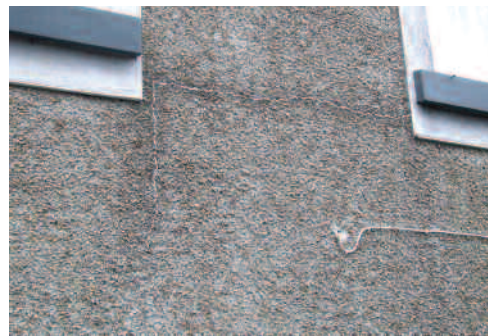
Figure 17 shows cracks in a render that have been made good with a sealant. The photograph was taken in late November after a few days of rain, although on the day it was taken there was no rain. The render immediately adjacent to the cracks is darker in colour than the body of the render, indicating that it is drying more slowly than the rest.

**Figure 17** Repaired cracks in external render.

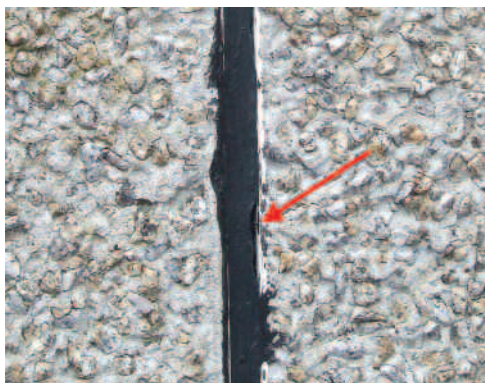
**Figure 18** Movement joint with bond failure in mastic.

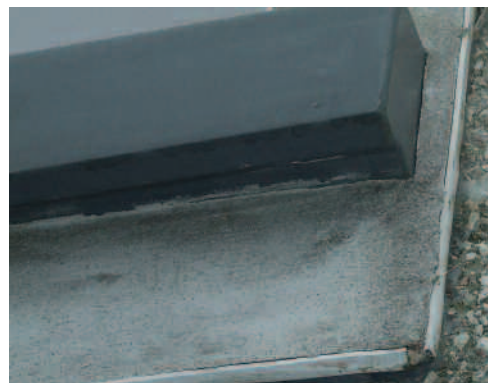
**Figure 19** Gap around sill.

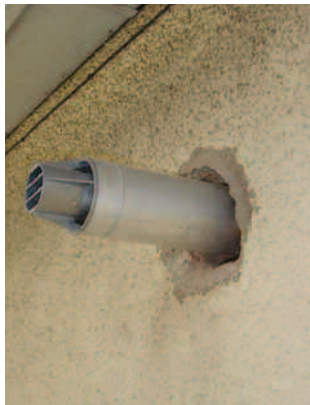
Figures 20 to 22 show a variety of service penetrations. Figure 20 shows a boiler flue shortly after installation but before the exterior was made good. The large amount of damage to the external insulation system will be difficult to seal effectively. If it did not have protection from the eaves, moisture ingress would be very likely. A cover plate would improve the appearance but if poorly sealed might not keep out water in a more exposed location. The cable in Figure 21 has sensibly been looped downwards to form a drip for rainwater, but the hole it passes through is not sealed. In Figure 22 the vent cover is sealed with a sealant (which may not be effective against such a rough background). One of the pipe penetrations is not sealed at all and the other has been poorly made good with a mortar. If the mortar used in the repair is stronger than the render or is poorly bonded then it is likely to allow moisture into the fabric.

**Figure 20** Extended boiler flue.

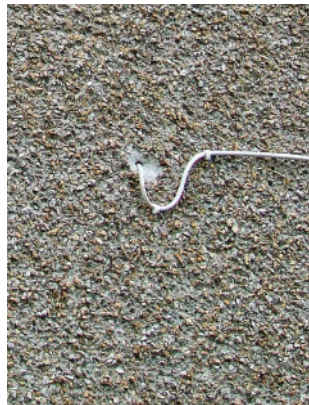
**Figure 21** Cable penetration.

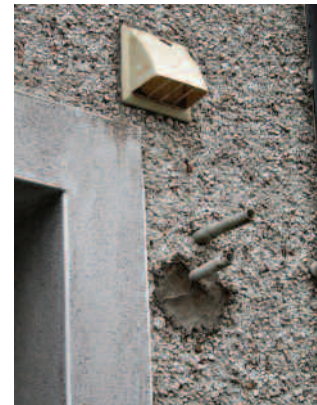
**Figure 22** Various service penetrations.

The original installer cannot be held accountable for these works since they were out of his control. However, the system should be designed with such abuses in mind, so that when moisture does penetrate it cannot do any damage.

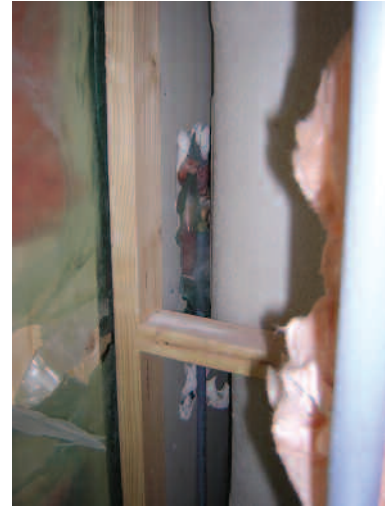
Many of the dwellings involved in the study would not have had a vapour control layer (the inclusion of which only became common practice in the 1960s). Modern timber frame constructions should, in theory, not suffer from interstitial condensation resulting from moisture vapour generated within the dwelling. However, as Figure 25 illustrates, vapour control layers are often damaged, both before occupation during the construction process and after occupation, by follow-on trades installing services.

**Figure 25** Damage to vapour control layer by 'follow-on' trade.

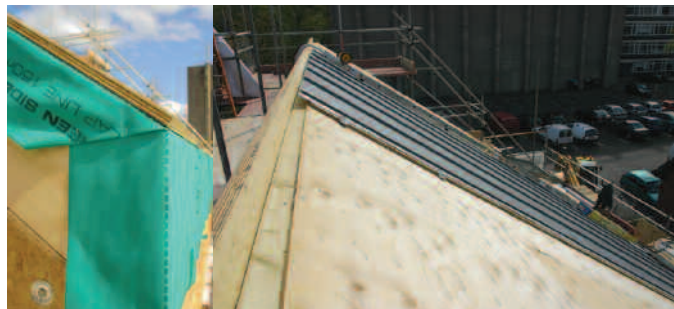
Figure 32 shows two images of a plywood deck over a roof cassette with a standing seam metal covering. There is no ventilation beneath the plywood deck. The integrity of the vapour control and the airtightness measures is being relied upon to prevent condensation on the underside of the plywood. Mounting the plywood on counter battens to create a ventilation path would have been preferable.

**Figure 32** Plywood deck over a roof cassette with a standing seam metal covering. A ventilation space beneath the plywood would be more robust.
