Full Fill Cavity Wall Insulation in Areas of Very Severe Exposure to Wind-driven Rain

A preliminary investigation into the impact of wider cavities on the possibility of rain penetration in new build masonry cavity walls

Date of issue: 14 March 2016

British Board of Agrément

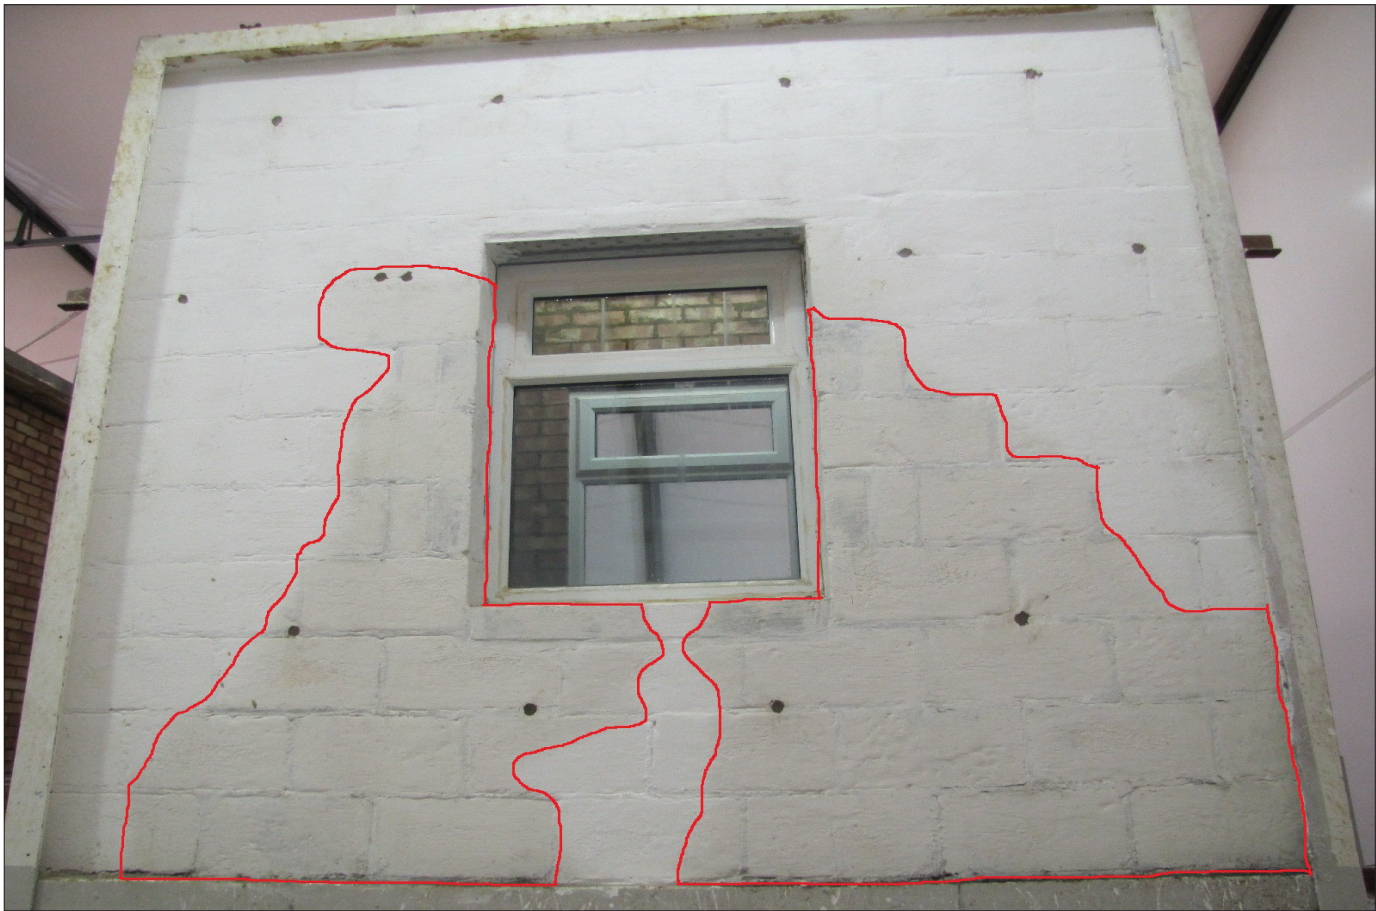
Figure 7 Wall 2 at end of test

Wall 2 (Filled Cavity): in the latter part of day 1 of week 1 of the test, damp areas began to emerge in mortar joints on the left hand side of the window detail. On day 2, these recurred and were mirrored by similar areas to the right of the window. The area of moisture expanded throughout the testing until, by the end of the final week, two broad arcs of dampness spread from either side of the window to the base of the rig. Figure 7 shows the two damp areas outlined in red. The black spots are the injection holes for the insulation.

Wall 2 (Filled Cavity): inspection of the cavity showed that the insulation had been installed to a good standard of consistency, apart from two very small voids which were found below and to either side of the window feature, but the transmission of moisture could not be attributed to these. No other feature suggesting an explanation for the transmission of moisture was observed.

Upon dismantling of the test rig, the insulation was found to have been installed at a significantly higher density than the target density of $24 \text{ kg}\cdot\text{m}^3$.

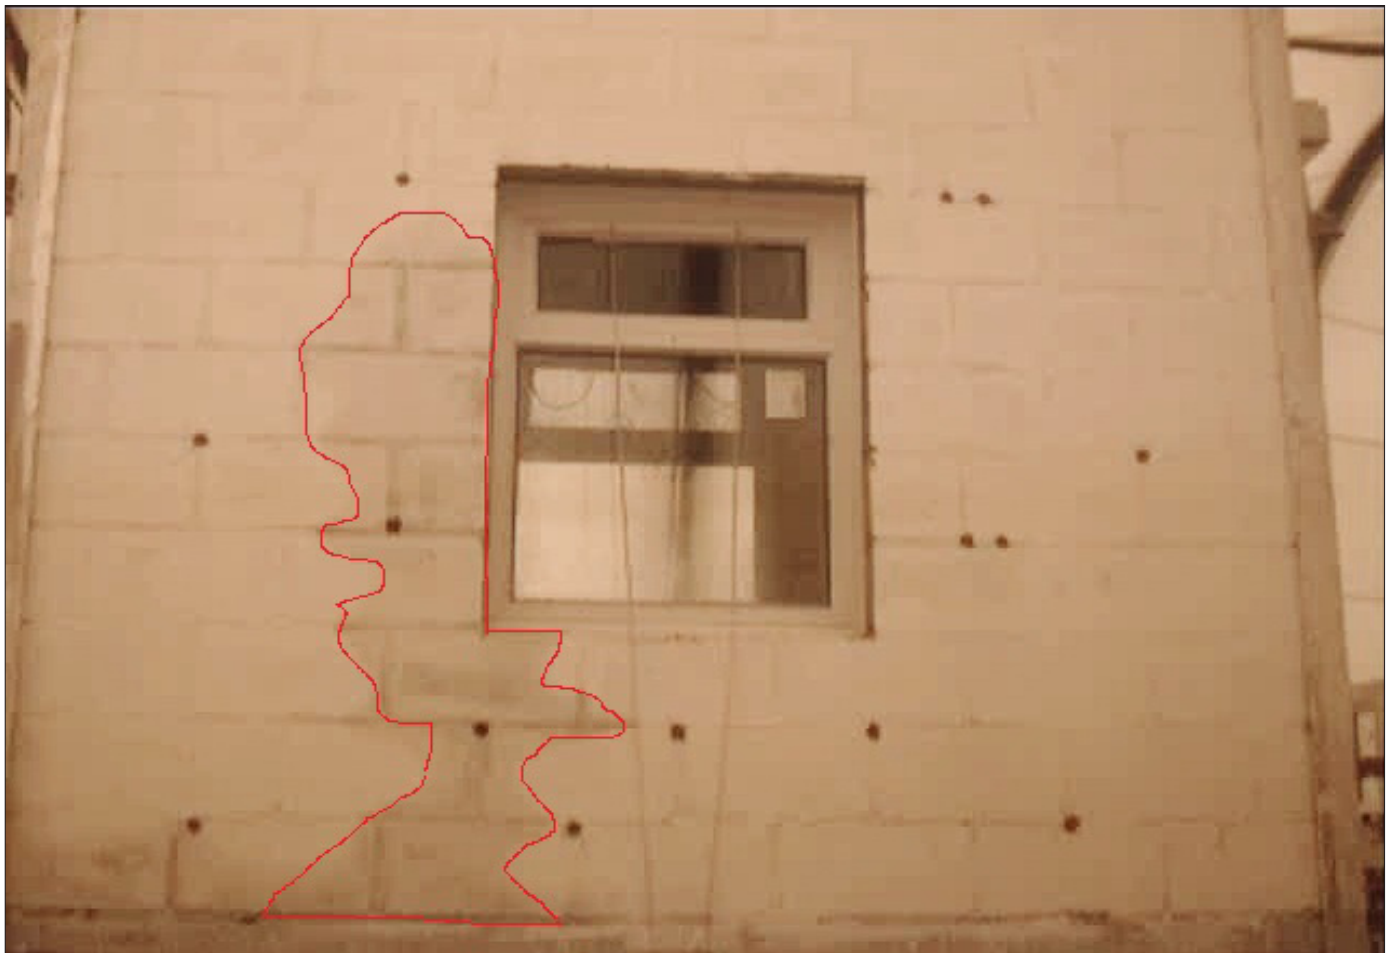
Figure 9 Damp area on wall 1

- no obvious issues were noted during the dismantling of the wall, ie there were no building defects and the fill appeared to be even and consistent throughout with no voids. However, subsequent density measurements showed that the insulation was installed at an average density significantly higher than the density certified for the product. This higher density was not uniform throughout the cavity, with variations being noted. Plugs of higher density insulation had formed, resulting in some surrounding areas of lower density, which may have provided paths for water penetration. This test was therefore not representative of the certified product and typical installations. Further testing of blown-in mineral wool insulation was discontinued at this point.

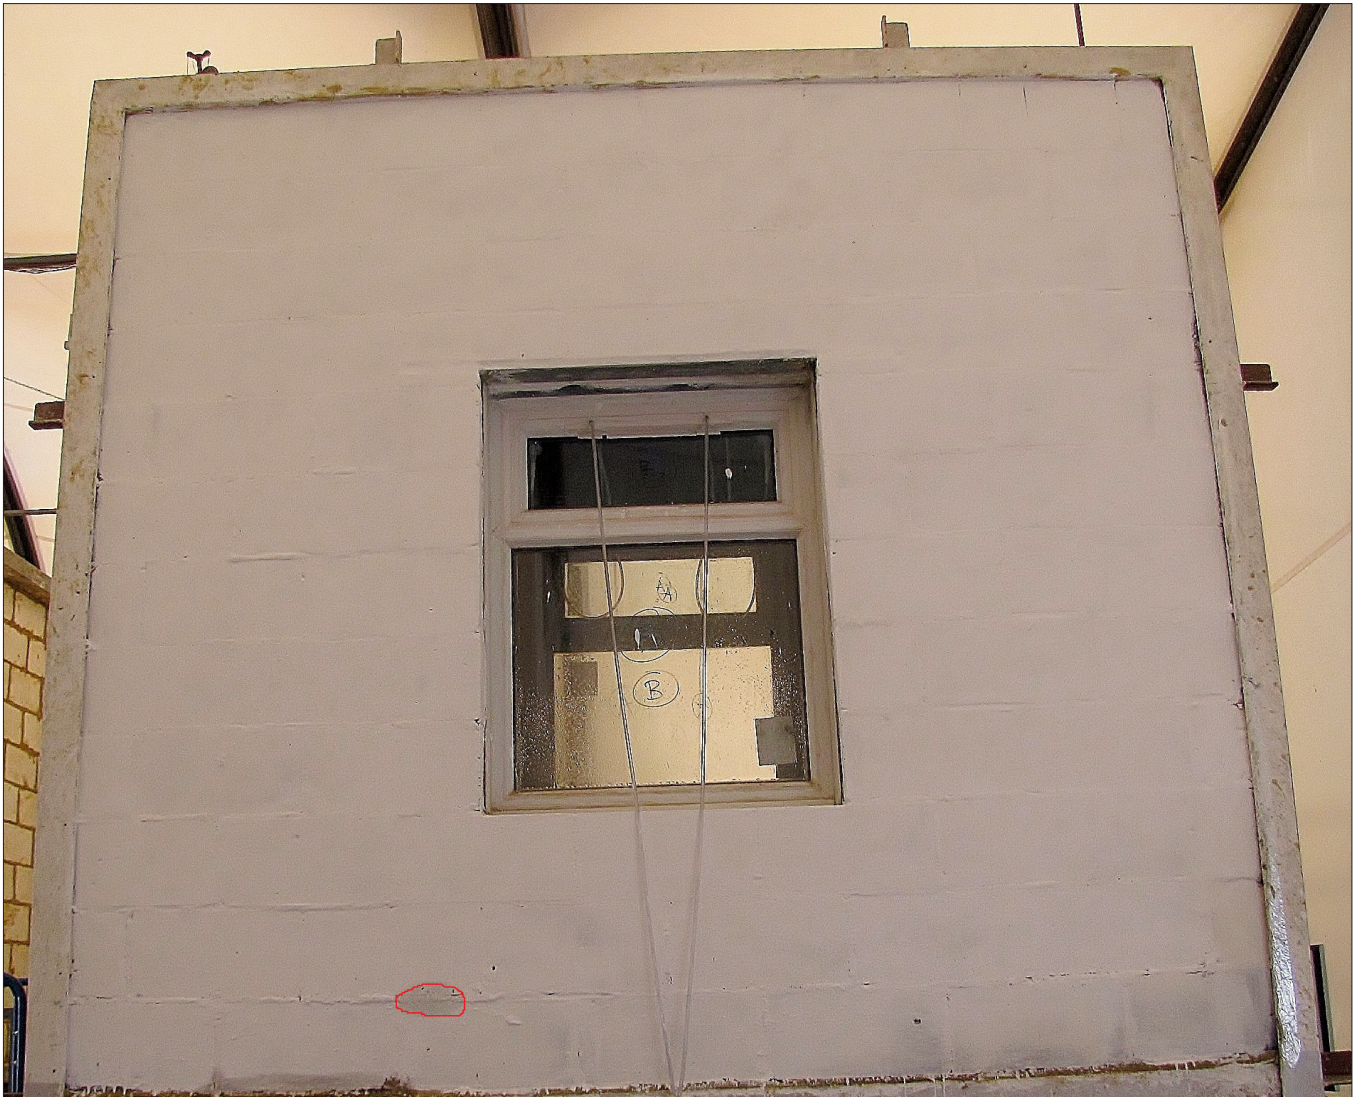
Figure 11 Damp area on wall day 3 of week 3

- the expanded polystyrene (EPS) bead insulation material saw no water penetration on wall 1 throughout the test. Wall 2 experienced a damp patch during day 3 of week 3, but this damp patch did not reappear during the remainder of the test (see Figure 11). Under the BBA's usual water penetration assessment criteria for full fill cavity wall insulation, this test result would not be deemed a failure when carried out on the standard wall configuration
- no obvious issues were noted during the dismantling of the wall, ie there were no building defects and the fill appeared to be even and consistent throughout with no voids.
