Assessment of MVHR systems and air quality in zero carbon homes

Primary research

August 2013

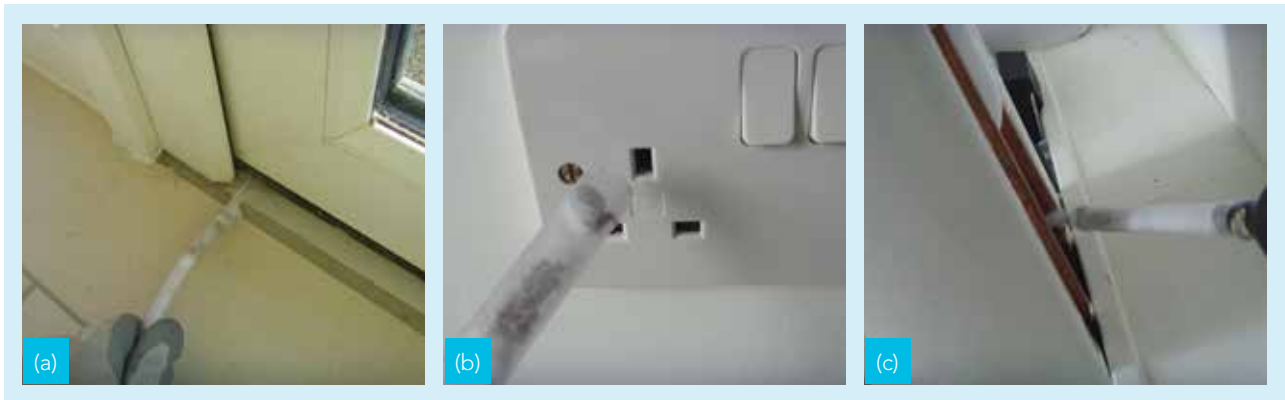
Airtightness testing was first undertaken in September 2010 during the finishing stage of construction. The homes were shown to have air permeability values in the range 2.6 to 5.7 m³/h/m². Main air leakage paths were identified and visualised using a smoke pencil during the pressurisation phase of airtightness testing. As expected air leakage paths were limited, although common ones were seen throughout the homes – such as around doors, through electrical wall sockets, around service pipe penetrations and light fittings (Figure 6).

Figure 6 Typical air leakage paths in Greenwatt Way homes (a) under back door (b) through wall sockets (c) through gap behind bathroom basin

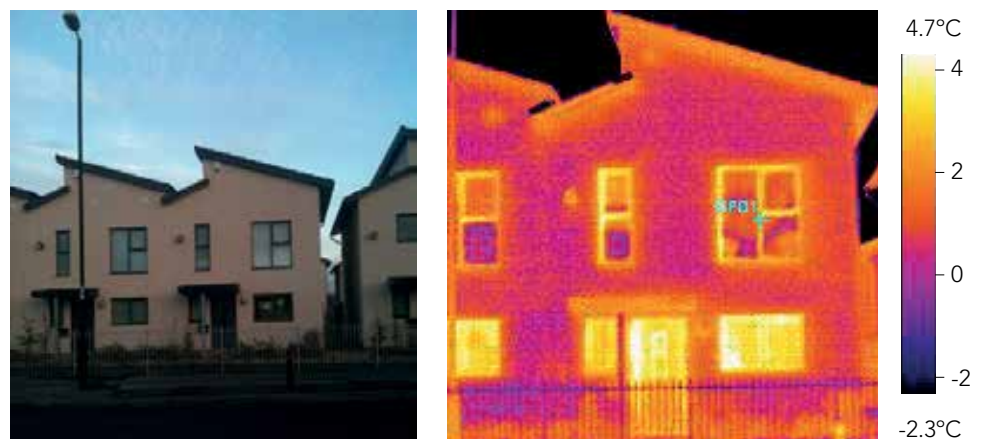
Figure 7 Front façade of Home 2. Corresponding thermal image shows uniform heat loss across the building façade

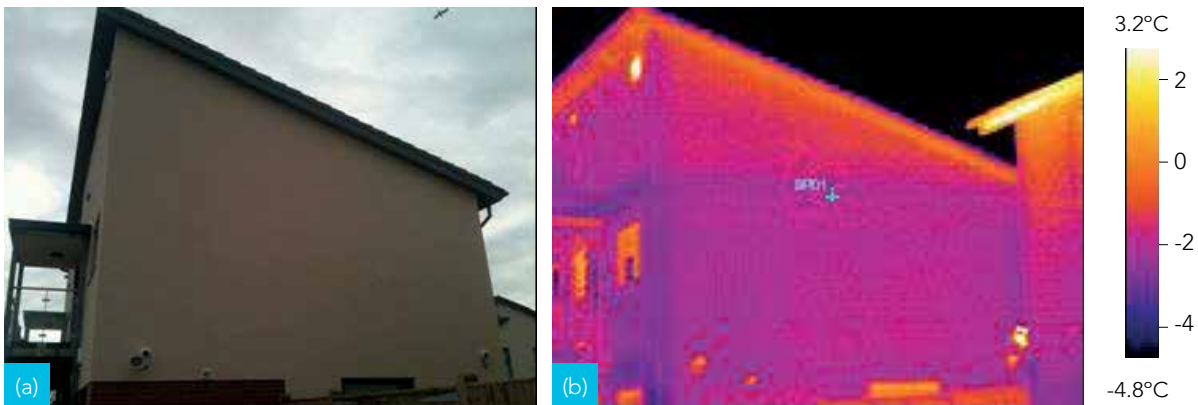
In general the homes were shown to be good from the point of view of the thermographic study undertaken and there were no obvious signs of heat loss through the external façade of the homes (Figure 7). The main heat loss paths in all home types appeared to be through gaps around windows and in particular the front entrance doors and rear patio windows (Figure 8). The other weak areas seen to be common in all of the houses were the poorly insulated roof lights above the staircases. On internal thermal images it was also possible to see signs of cold air ingress through gaps around loft access hatches. In the case of the two flats, especially Home 5, it was possible to see a difference in the amount of heat being lost between the internal area of the flat and the sloping roof area (ie the loft area above the flat). There seemed to be more heat being lost from the roof area, which may suggest heat getting up into the loft area and leaking out through the external walls (Figure 9).

Figure 9 (a) West façade of Home 5, (b) corresponding thermal image shows some heat loss at eaves level

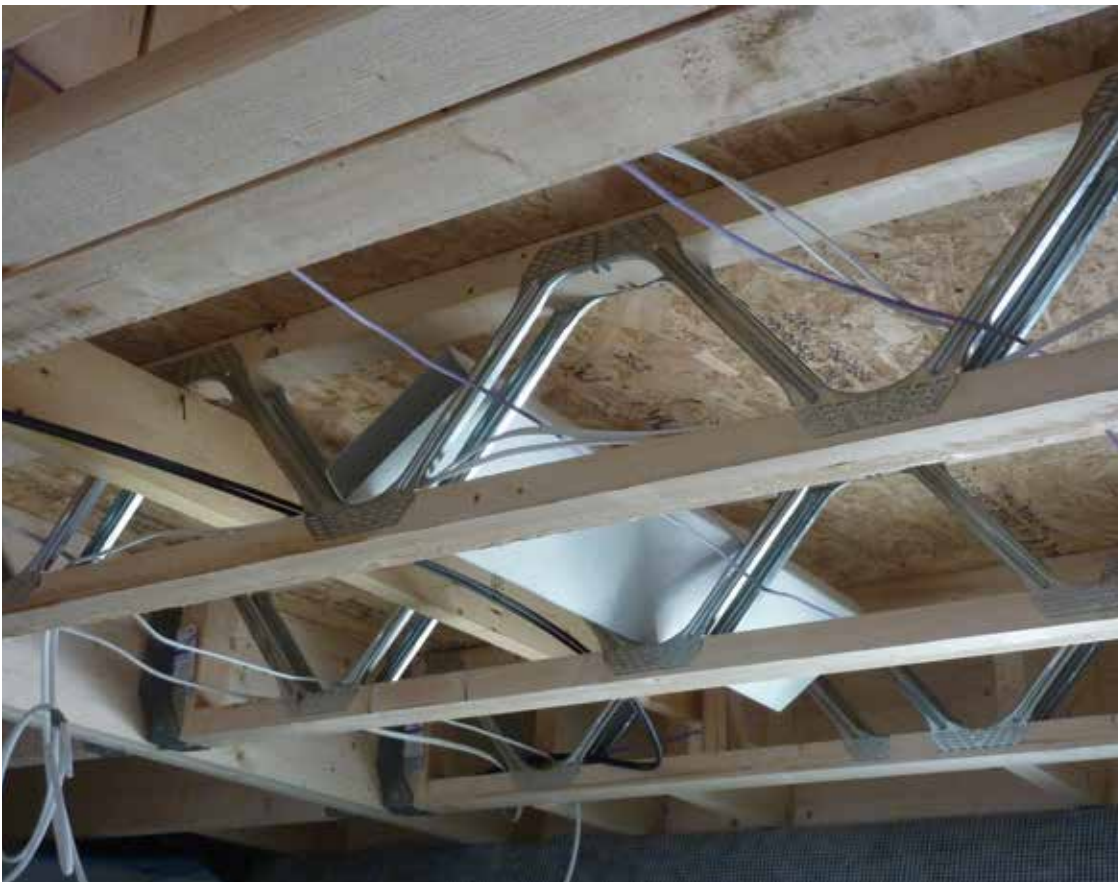
Figure 12 Flat ductwork (as specified) clashing with joist webs

- **Ductwork type:** The original ductwork procured (flat cross section) was found to be impractical to use in the homes as constructed, clashing with the webs of the floor joists – thus making straightforward installation impossible. Replacement with ductwork of round cross section allowed direct runs from risers to air valves and meant that ductwork could be installed in long lengths, thereby minimising the number of bends and connections required. There were short sections of flexible duct in some locations that created very significant restrictions to air flow due to poor installation practice.

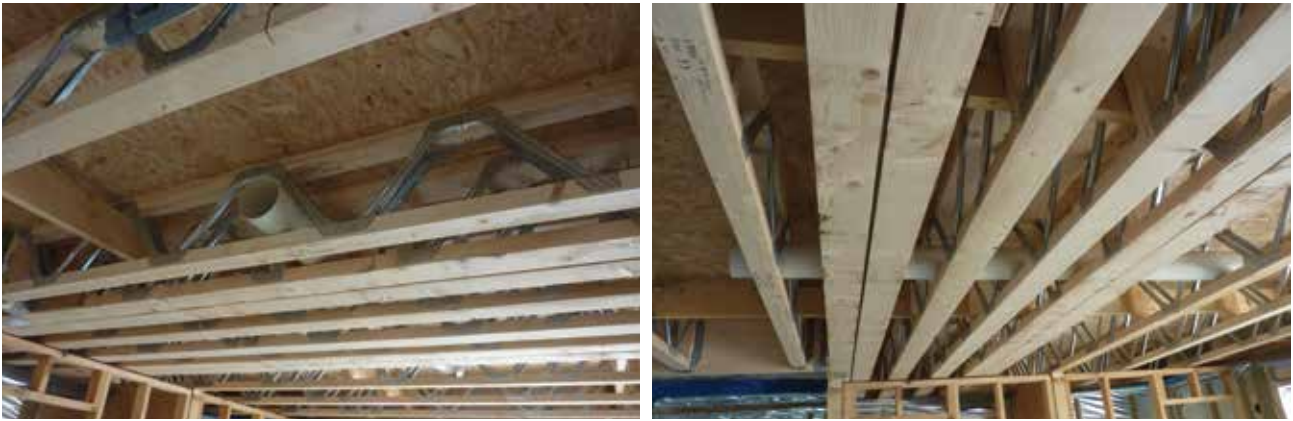
Round ductwork was subsequently procured and installed within the floor joists. Figure 13 depicts how the use of this type of duct minimised the need for any additional bends to be installed between the riser and the room valve.

Figure 13 Round ductwork allowed direct runs from risers to air valves and could be installed in long lengths, minimising the number of connections

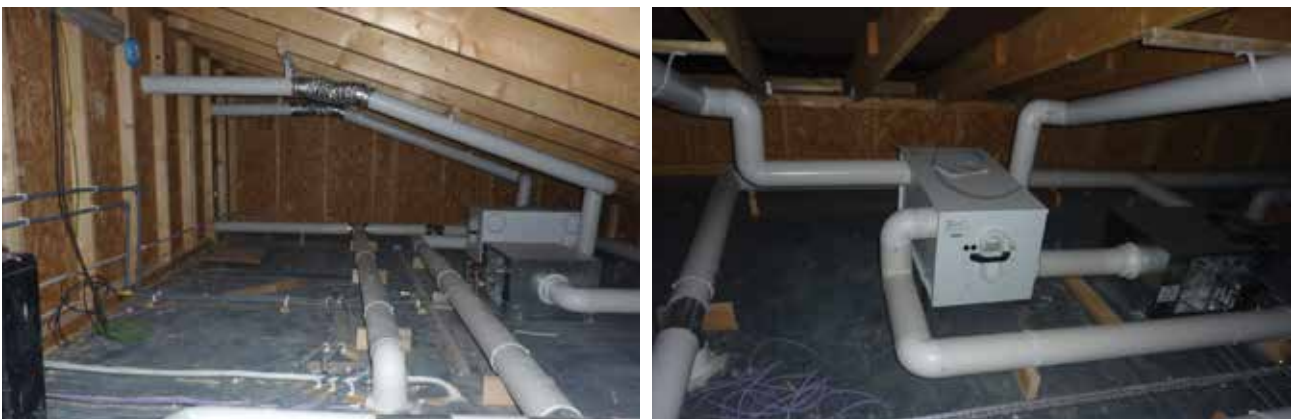
The MVHR fan units had also been installed, along with the associated loft ductwork. It was immediately evident that very significant lengths of ductwork were located in the unheated loft. Inspection of the roof construction revealed that the ceiling was an off-site produced panel and no provision had been made for including horizontal ductwork runs within the panel. As no space had been made available within the insulated envelope for ductwork to run internally, the only option was for all of it to be located in the loft. The general layout of the ductwork in the loft can be seen in Figure 14, all in accordance with the outline drawings issued by the M&E designers.

Figure 14 MVHR fan unit and associated distribution ductwork in the loft

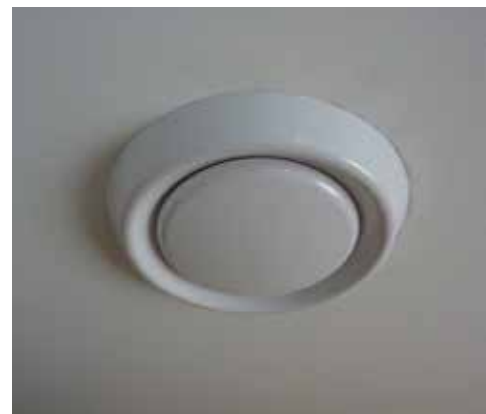
A review of the setting of the air valves, following recommissioning, revealed that most of them had been closed in very tightly (Figure 17). The reason for this was to minimise the potential of cold supply air 'dumping' down into the rooms and causing discomfort – a situation exacerbated by the wrong types of air valve having been used for supply. Closing the valve results in the supply air jetting into the room and mixing with the room air before it enters the zone occupied by people in the room. The extract valves had been closed to near shut because the model of MVHR fan unit installed in these homes only has a single speed control for both fans. Therefore, increasing the fan speed to overcome the resistance in the supply valve results in the extract air flow rate increasing. To return the air flows to balance the extract, valves have to be closed by approximately the same amount as the supply valves. The result of having the valves nearly closed is that the fans must run at a higher speed to achieve the design air flow rate than if the correct valves had been installed and set correctly. This would have been of considerable detriment to the efficiency of the systems.

Figure 17 Supply and extract valve commissioned to near shut

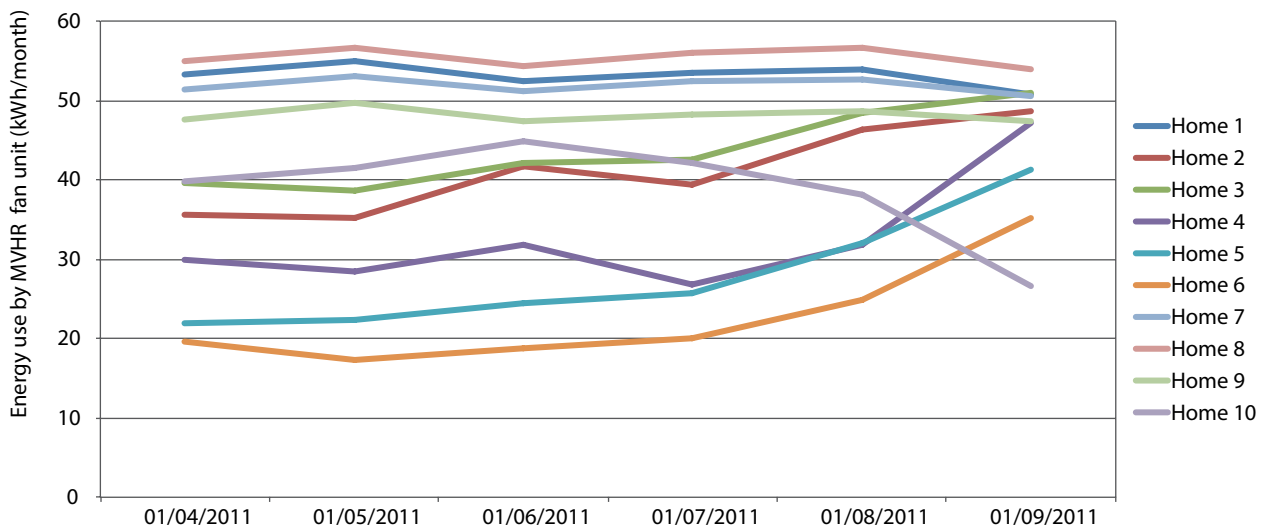
Overall the results clearly indicate high fan power resulting from poor system commissioning. This can be identified as the cause of the high fan power, since the installation of the ductwork was reviewed during the installation/construction process and was found to be above average, with an appropriately sized duct being used for the air flow rates being handled.

In Figure 18 Home 10 appeared to have the opposite trend to Homes 1 to 9, with the energy use of the MVHR fan unit falling over the summer. However, this was identified as being due to the failure of the fan unit, which when inspected in October had totally failed with neither fan running.

Figure 18 Monthly energy use by the MVHR fan units for Homes 1 to 10

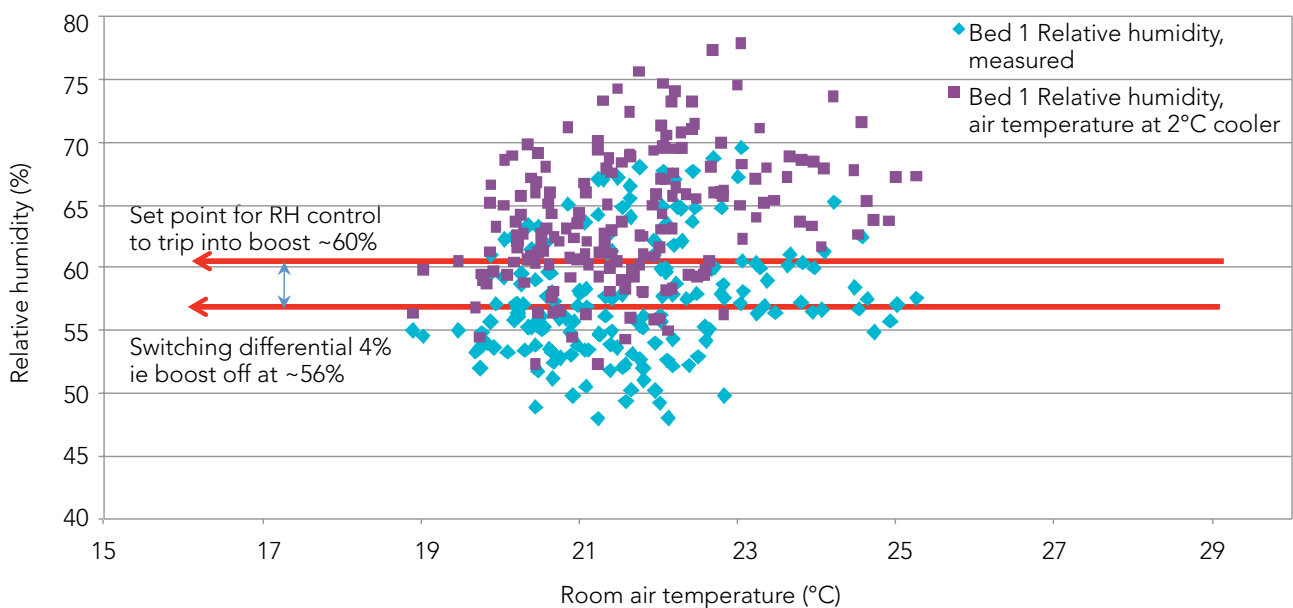
Figure 21 Room air conditions showing 'boost on' and 'boost off' relative humidity values, and the effect of reducing room temperature by 2°C on relative humidity

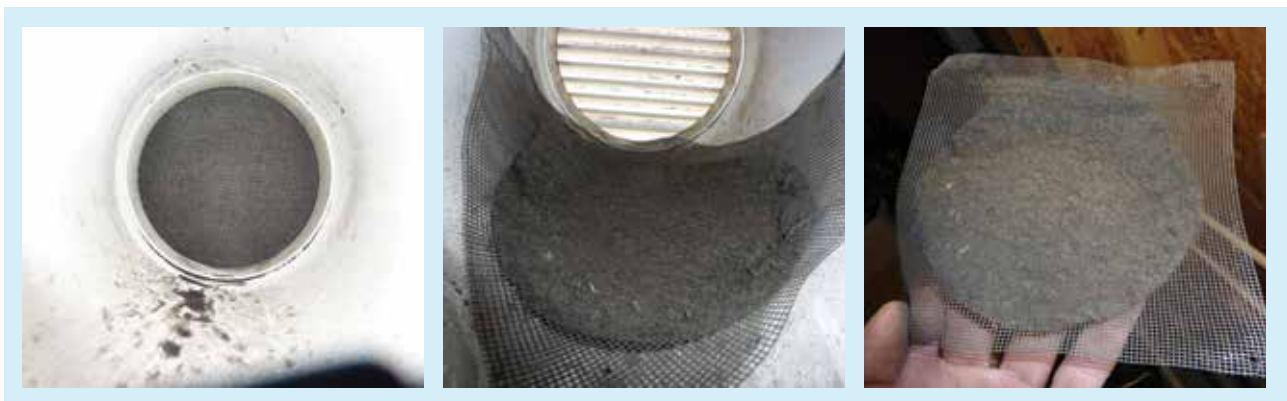
Following an assessment of the air flow rates after the independent recommissioning of the MVHR system in the homes, it was noted that the air flow rates in Home 9 were falling during September 2011. This was traced back to clogging of the fly screen in the inlet terminal, in a location within the loft space which was hard to access. The fly screen was removed and air flow rates returned to the commissioned values. However, it was decided that the fly screens in all homes should be inspected. The fouled fly screen in Home 9 had reduced the total supply air ventilation rate down from 24 l/s to below 20 l/s. When the assessment of the fly screens in the other houses was undertaken in October, they were all found to be nearly totally blocked. Figure 22 shows images of one screen as it was removed.

Figure 22 Fly screen removed from a supply air valve – almost totally blocked by build-up of debris

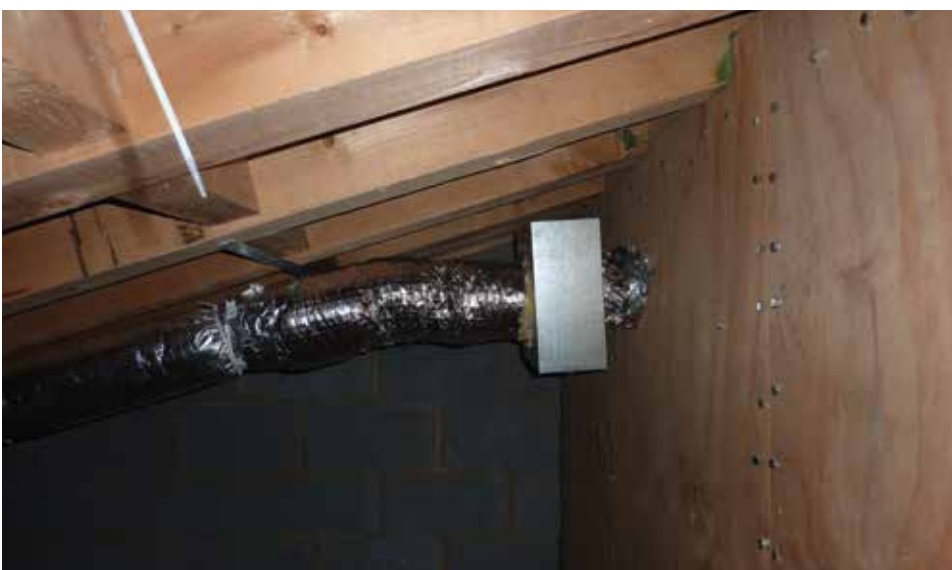
The MVHR fan units installed in all of the homes have supply and extract air filters included within their casing. However, access to them requires the removal of 10 screws. This makes regular checking and replacement of the filters unlikely. This was evident after only a few months' occupation, when it was noted that several of the supply air filters were very dirty. The options for installing additional filtration were: to upgrade the filters within the MVHR fan unit, possibly with a pre-filter and then a high grade final filter, or to place alternative filtration close to the supply air valve. The latter option was chosen as more practical, since it allowed an easily accessible filter to be placed in the first section of the ductwork, and required no tools for removal. To increase accessibility the approach adopted was to place filter boxes directly on the internal face of the roof space wall in the supply air duct (Figure 23). The type of filter installed was an F5, a slightly higher grade (finer) than the filters installed in the MVHR fan units. Following the remedial work the filters were to be inspected as part of routine maintenance and cleaned or replaced as appropriate.

Figure 23 Filter box installed in supply air duct inside loft

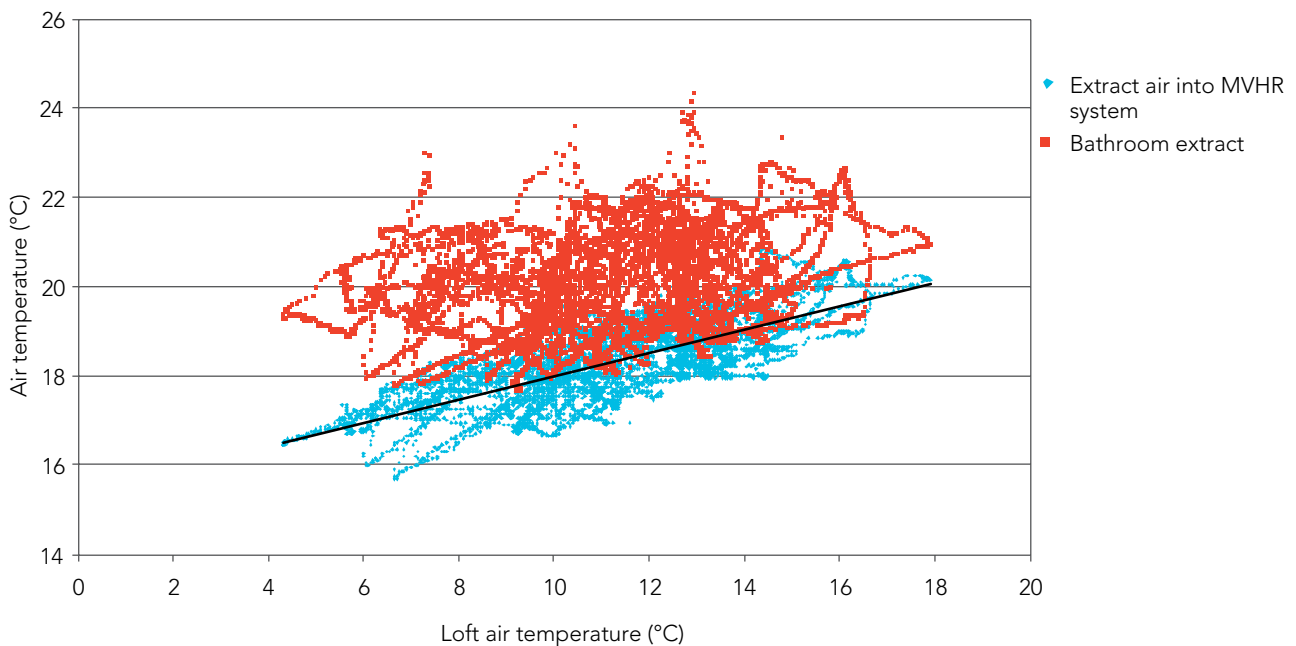
Figure 29 Comparison of bathroom extract air temperature as it leaves the thermal envelope and as it enters the MVHR fan unit, as a function of loft air temperature

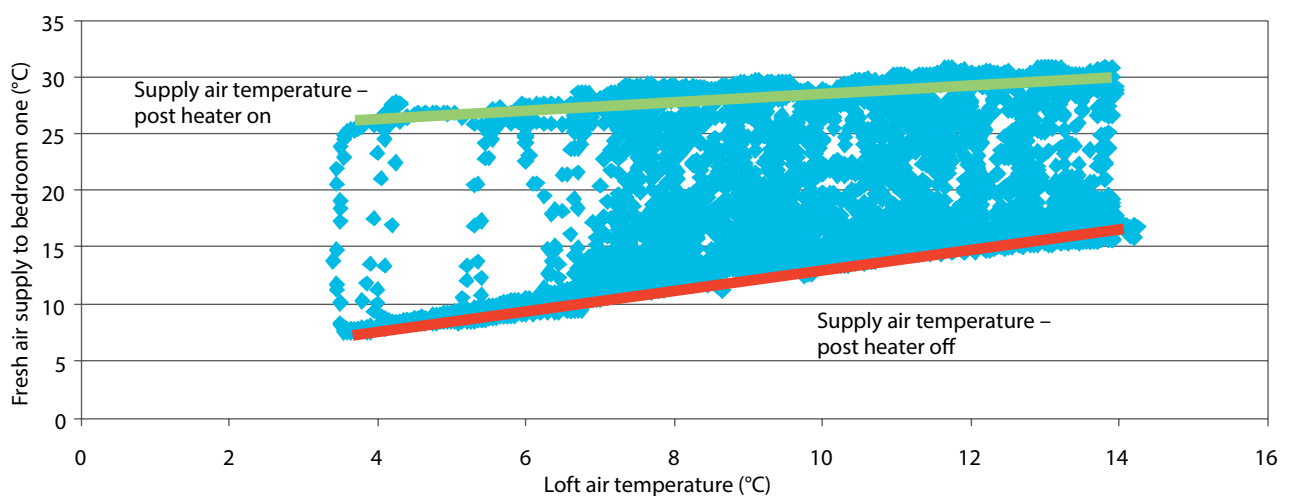
From Figure 30 it is clear that when the post heater is not running there is a strong correlation between the supply air temperature and the loft air temperature. This reinforces the argument that while the heat exchanger is itself able to recover up to 90% of the heat from the extract air, a very significant percentage of heat from the extract air and the supply air is then lost, both through the MVHR fan unit casing and through the ductwork as it is delivered to the living rooms. The effect of these losses on the system installed in Home 9 is that when the loft air temperature is around 5°C or below, the supply air temperature to the living rooms falls to below 10°C. Air supplied into a warm room at this temperature will tend to dump unless the supply air valve has been very carefully commissioned. If this is not the case then the supply air will be noticed as a cold draught and result in discomfort. In some cases it is possible that such discomfort may lead to an occupant turning the MVHR system off.

Figure 30 Relationship between supply air delivered to bedroom one and loft air temperature

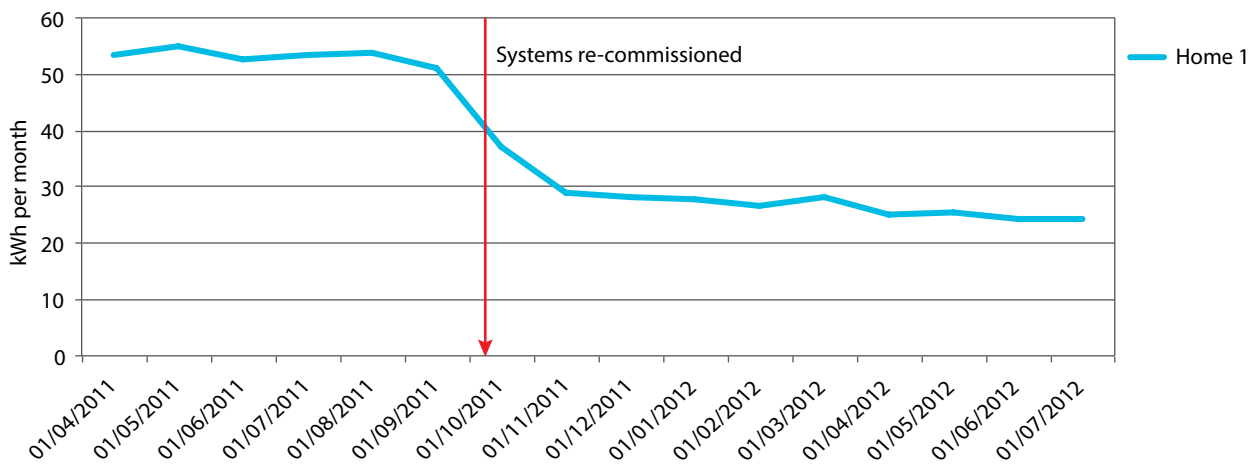
Following the replacement of the MVHR fan unit in Home 1 with a significantly larger fan unit, it was hoped that the energy use would fall due to the fans being able to handle the relatively high air flow rate without having to run near to their maximum speed. Figure 35 confirms that the new, larger MVHR fan unit's energy use was significantly lower (around 50%) than that of the original fan unit.

Figure 35 Energy use before, during and after the period of remedial work (October 2011) for Home 1

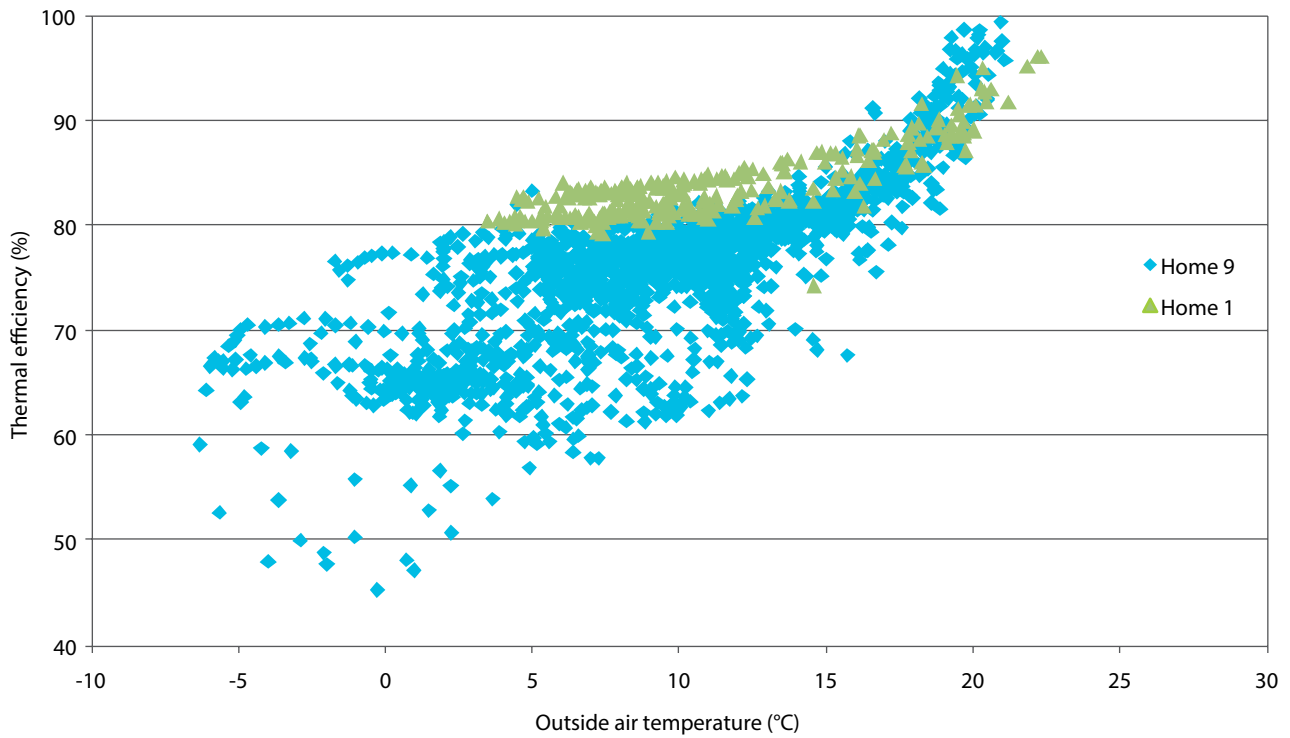
Comparison of the calculated thermal efficiency of the MVHR fan units installed in Home 1 and Home 9 can be seen in Figure 36. From this data recorded over the winter and spring period of 2012, it is clear that the new, larger MVHR fan unit installed in Home 1 is significantly more efficient than the original fan unit installed in Home 9. Both of these MVHR fan units have been type-tested in a laboratory and achieved thermal efficiencies of around 90%. What is evident from the results presented in Figure 36 is that this efficiency is achieved only when the outside air temperature and the loft air temperature are at or above 20°C. This suggests that although the thermal performance of the casing of the new MVHR fan unit is significantly better than the original fan unit, it still loses up to 10% when installed in a cold loft.

Figure 36 Thermal efficiency of MVHR fan units for Homes 1 and 9

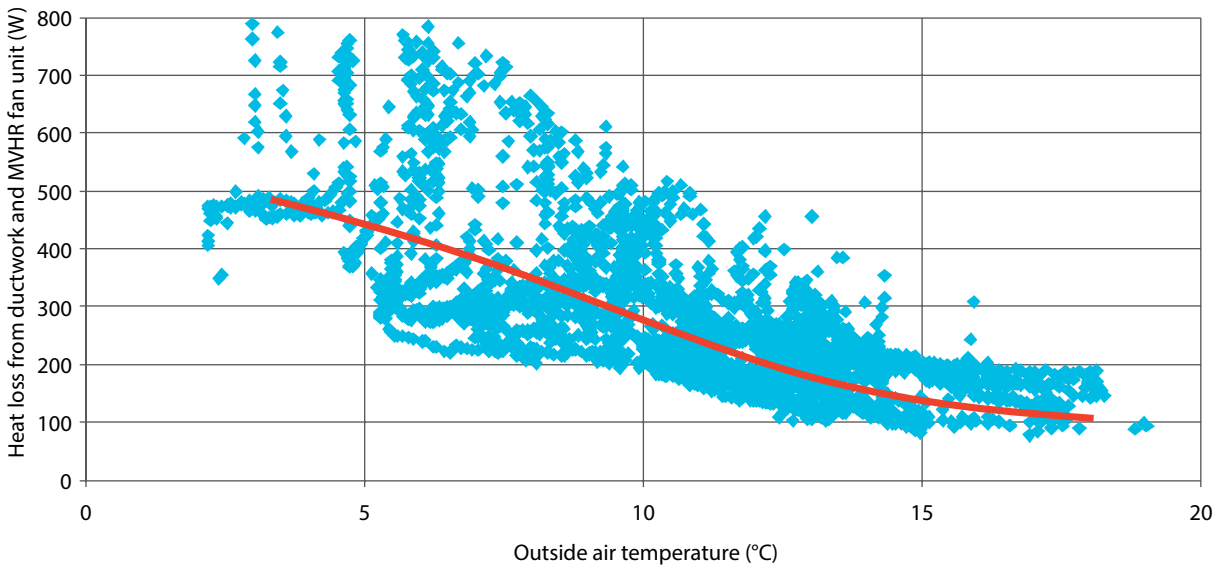
Figure 37 Heat loss from ductwork and MVHR fan unit for Home 9

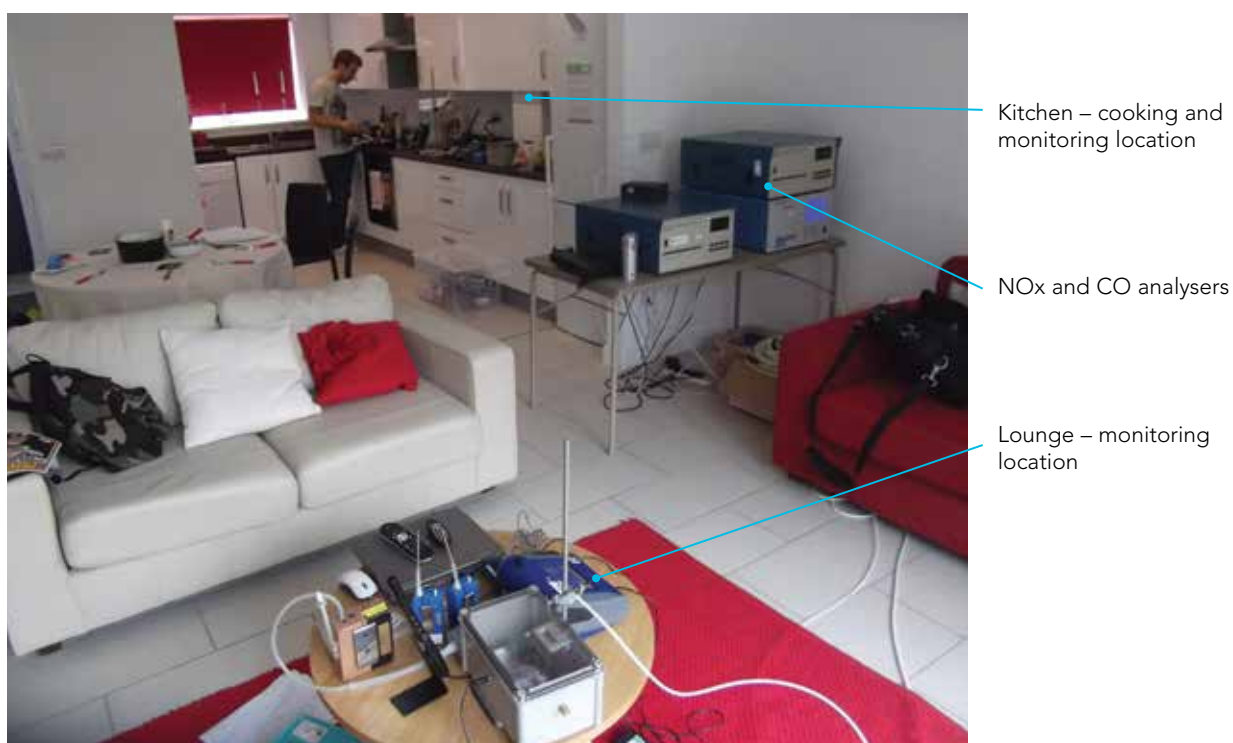
Figure 42 Overall layout of monitoring equipment in the show home
