# Learning the lessons from systemic building failures

This review was written by Keith Ross, BRE.

© NHBC Foundation  
NF10  
Published by IHS BRE Press on behalf of NHBC Foundation  
September 2008  
ISBN 978-1-84806-046-3

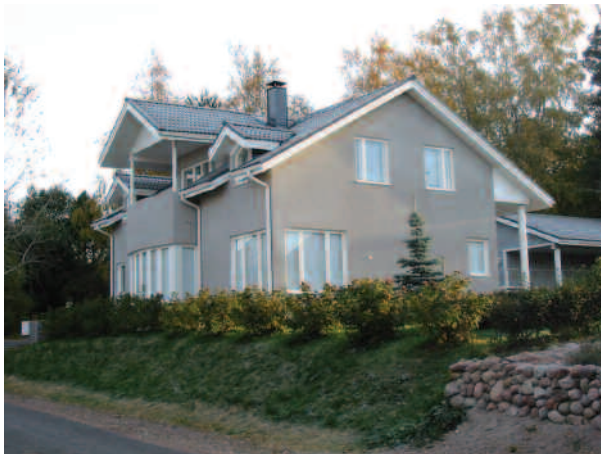
There appears to be a belief on the part of some designers that 'modern' buildings do not need 'traditional' detailing. Many traditional details, such as a projections at eaves and verges (see Figure 2) and a drip on a window sill, were developed to protect the structure from the weather by providing a degree of shelter and directing rainwater away from the building.

**Figure 2** Generous overhangs at eaves and verge help to protect buildings from the weather.

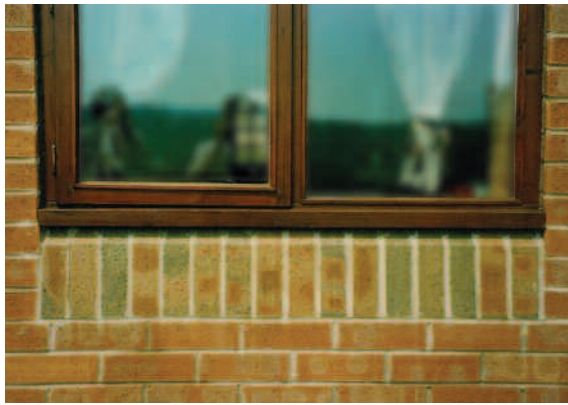
Omitting a drip from window subsills, as illustrated in Figure 3a, will increase rain absorption of the wall below. With no projection at the sill, water streaming down the window will be directed over the brickwork below, increasing the risk of rain penetration. This would have been potentially quite serious in the days of solid masonry construction, but now that cavity construction is the norm

the water can usually be safely discharged via weep holes. However, if there were to be debris in the cavity (see Fig. 3b) or mortar accumulations on the wall ties the risk of rain penetration would be increased by the omission of the drip on the sill.

**Figure 3a** Flush brick-on-edge subsill.

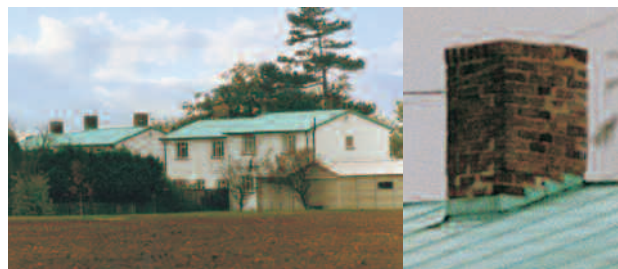
Sheet metal has been used as a roof covering for centuries. Initially, cast lead was the main material and it was used on many ancient buildings, but more recently other metals such as copper, zinc, aluminium and stainless steel have been used, as in Figure 14.

Figure 14 Copper-covered roofs on houses in open country. These roofs were laid in 1947 and have given excellent service.

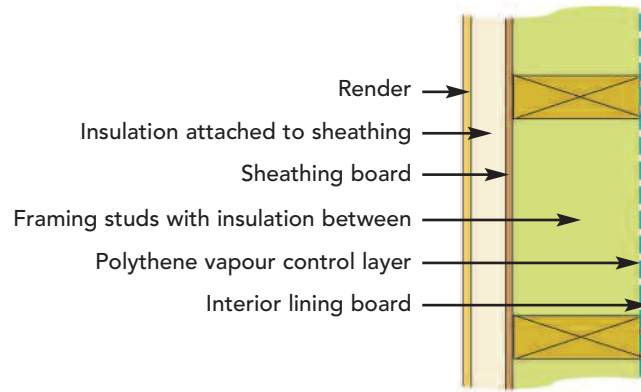
In Sweden, following investigations into problems resulting from moisture ingress into timber framed walls during construction (see section 2.2), problems were noted in timber framed buildings directly clad with external insulation systems that could not be explained solely by construction in wet weather. A report<sup>12</sup> by SP Technical Research Institute of Sweden states that damage was caused by water infiltration through defects in the façade after completion of the house. Figure 16 shows a cross section of a

In a number of surveys undertaken by SP they have found that construction detailing around fastenings and joints on the façade are unsatisfactory from the perspective of preventing moisture entering the fabric. In particular, cracks have opened up at the side junctions of balconies, windows, terraces and canopy attachments. Below these areas moisture contents in the sheathing board have been found to exceed 28%.

The SP report points out that in most cases problems noted to date have been found when the wall has been opened up for other reasons, giving reason to suspect that there will be significantly more damaged houses as yet undetected. In June 2007 funding was secured for a research project to undertake a comprehensive review of the extent of moisture damage in rendered, undrained walls. The aims and methodology of that project are detailed in a further SP report,<sup>13</sup> which concludes that undrained constructions such as that in Figure 16 represent a high risk from the point of view of moisture ingress and should not be used.

**Figure 16** Cross section of wall found to be susceptible to moisture penetration in Sweden. Based on a diagram in reference 12.

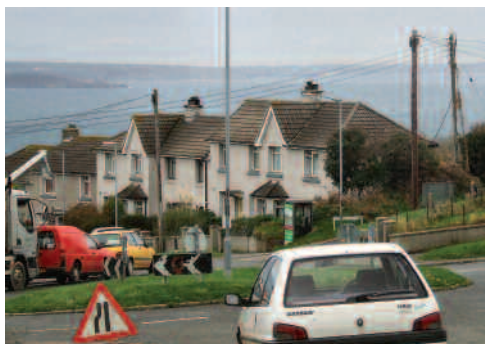
External insulation is normally applied directly onto masonry substrates, and the history of performance as a retrofit measure is good. The dwellings in Figure 23 were externally insulated some 20 years earlier and have performed very well in an exposed location in Cornwall. The system used was conventional render over mineral wool batts applied as a retrofit measure to previously rendered hollow blocks.

Sealants are approaching the end of their design life (some have already been replaced), but as the substrate is rendered block no serious problems would be anticipated.

**Figure 23** Good performance of 20-year-old render over external insulation.

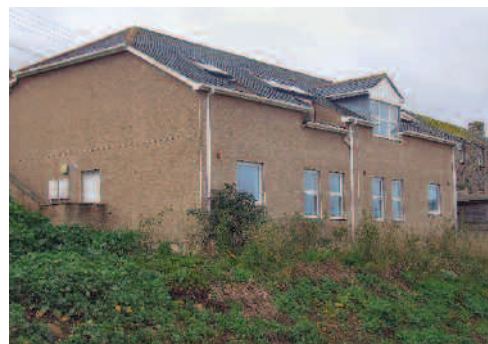
Figure 24 shows a development of four flats built in 1999 with externally insulated solid walls. The façade shown faces directly onto the sea in an exposed coastal location. Careful attention to detailing around openings (eg the use of stainless steel render stop beads to allow robust silicone sealant joints to be achieved against the window frames) has contributed to the good performance.

**Figure 24** Careful detailing has given good performance in an exposed coastal location.

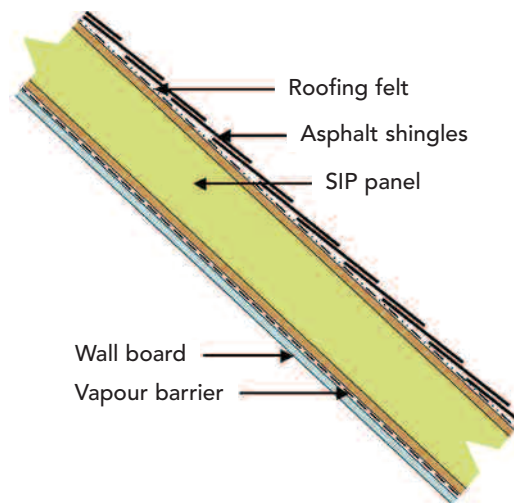
A typical roof construction described in the reports related to Juneau is shown in Figure 28.

If moist air leaks between the panels, condensation is very likely to occur on the underside of the roofing felt. The lack of ventilation between the SIP and the roofing felt means that any condensed moisture will not be able to dry out and moisture will accumulate. It is this fact that caused the panels in Juneau to rot. Reacting to the problem the City and Borough of Juneau Building Division issued a policy on SIP roof panels (see Appendix B). In it they listed the three most significant factors contributing to the failure of SIPs as:

Figure 28 Typical SIP roof construction used in Juneau.

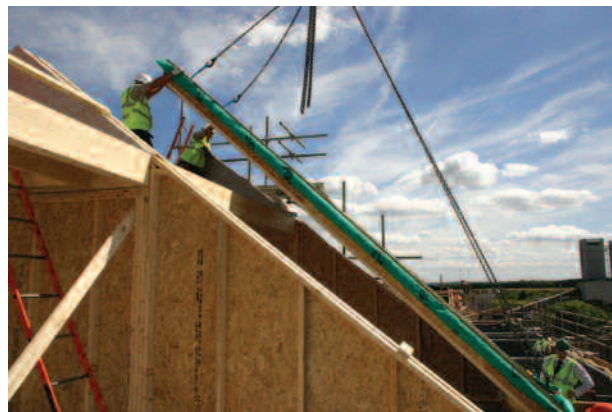
timber than a standard roof, usually needing only purlins for intermediate support (see Figure 29). This gives a space that is completely open, and simpler to detail in terms of airtightness and thermal insulation. The speed of construction is also increased and it is quite feasible for a watertight roof to be placed in a single day.

Figure 29 Roof cassettes being installed.

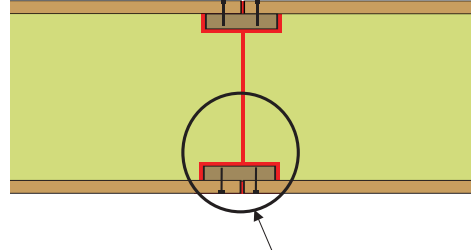
A continuous seal in this area is critical

It is most important that the seal is achieved on the lower side of the joint, is continuous and extends as far as possible through the panel (see Figure 31). If only the top side of the joint is sealed, condensation could still occur below the upper sheet of OSB, leading to the possibility of rot.

**Figure 31** Seal most critical in lower half of panel.
