Thermal imaging report guide

How to interpret the results of a thermal imaging survey

Guide

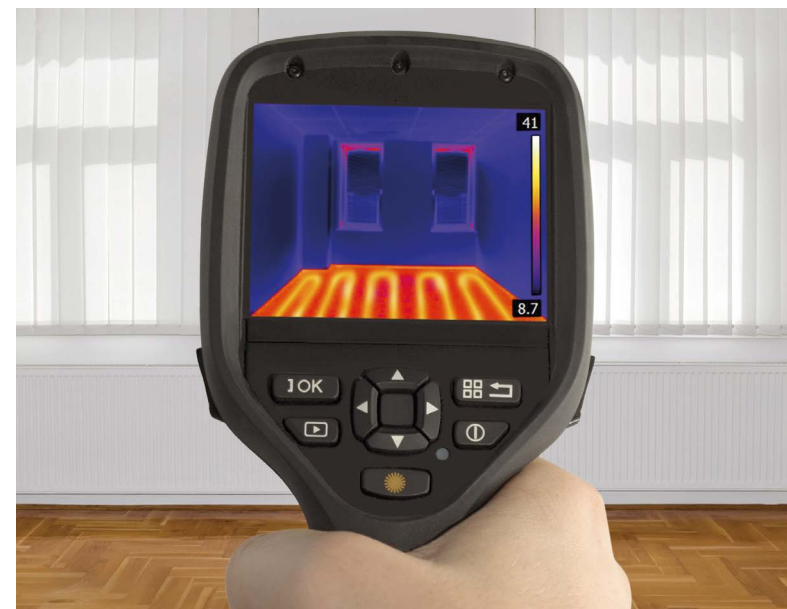
A thermal imaging camera showing underfloor heating pipe layout

Some new homes are now fitted with underfloor heating, the performance of which is determined by the even installation of heating pipework loops in the floor. Thermal imaging may also be used to determine whether these loops have been installed satisfactorily, in accordance with the design layout.

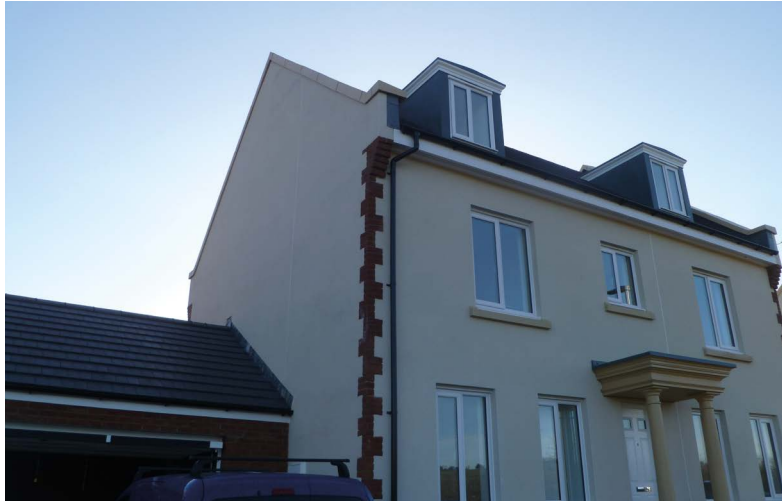
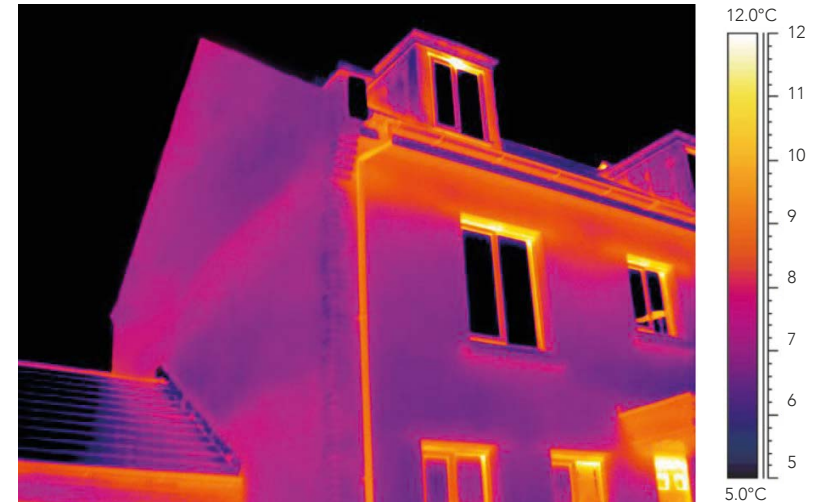
Thermographic image 1

Thermographic image 1: Good construction

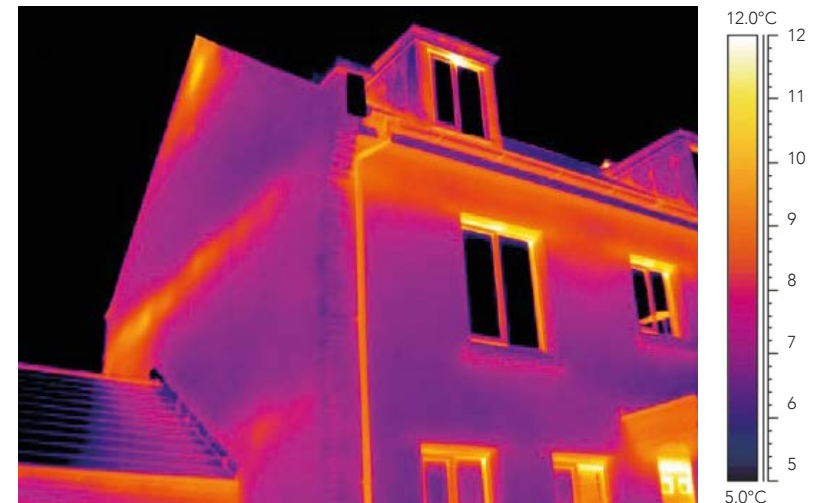
Thermographic image 2

Thermographic image 2: Potential fault

The brighter yellow areas at the wall apex and in line with first and second floor joists indicate a higher surface temperature in these places, suggesting higher local heat loss. This may be due to inconsistency in the installation of the insulation batts with some areas of the cavity having gaps between the batts or a build-up of mortar debris.

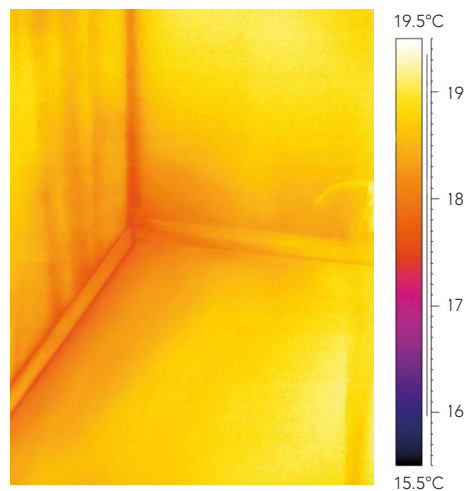
Thermographic image 3

Thermographic image 3: Good construction

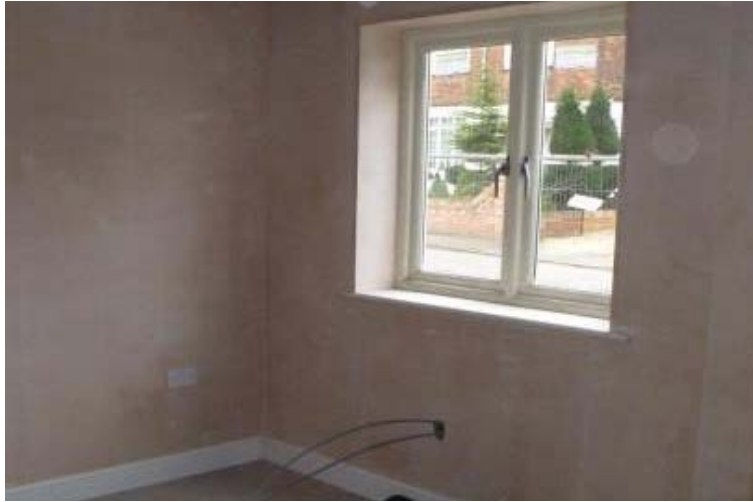
Thermographic image 9

Thermographic image 9: Good construction

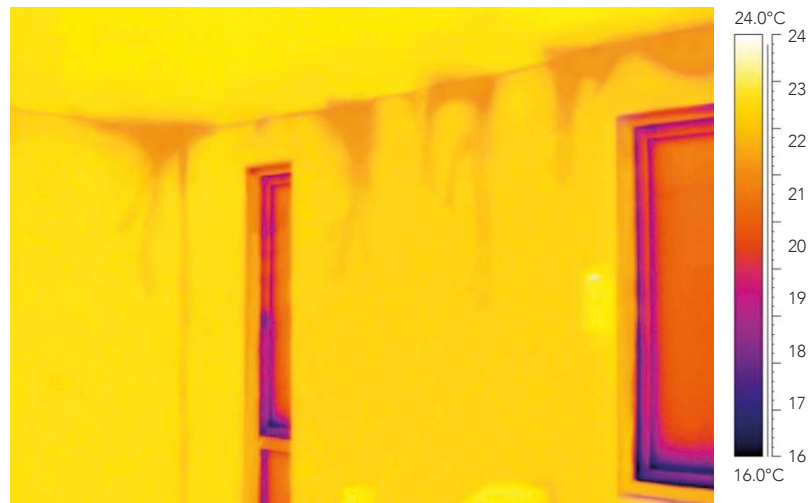
Thermographic image 11

Thermographic image 11: Good construction

It is normal to detect slightly lower temperatures at external corners of walls, both horizontal and vertical; this is caused by slightly higher level of heat loss expected in these locations and is not a sign of a problem.

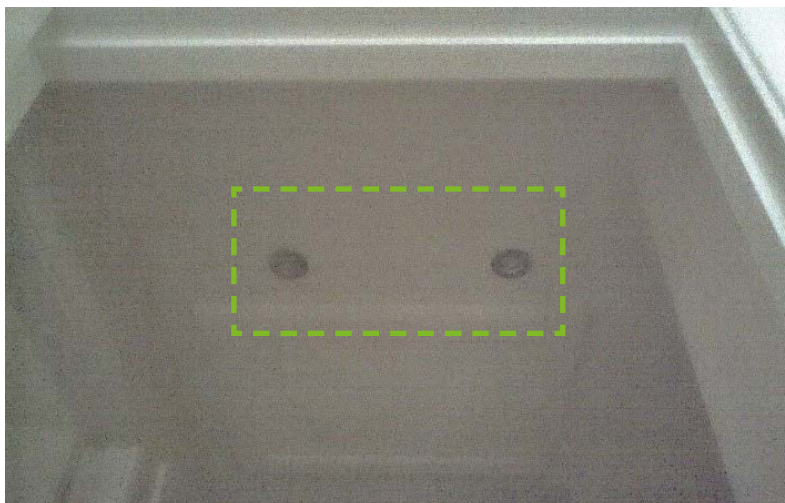
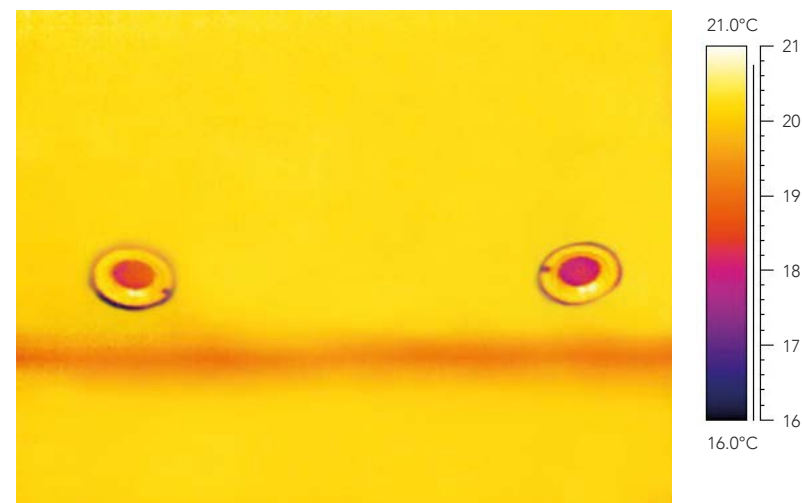
Thermographic image 13

Thermographic image 13: Good construction

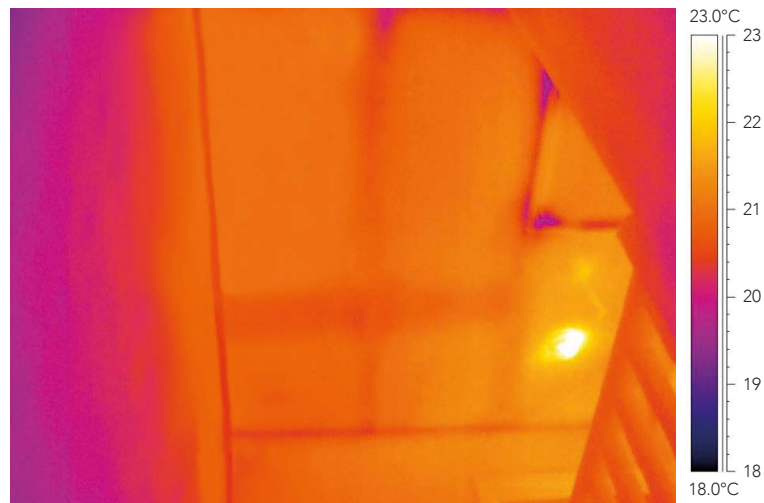
Thermographic image 15

Thermographic image 15: Good construction

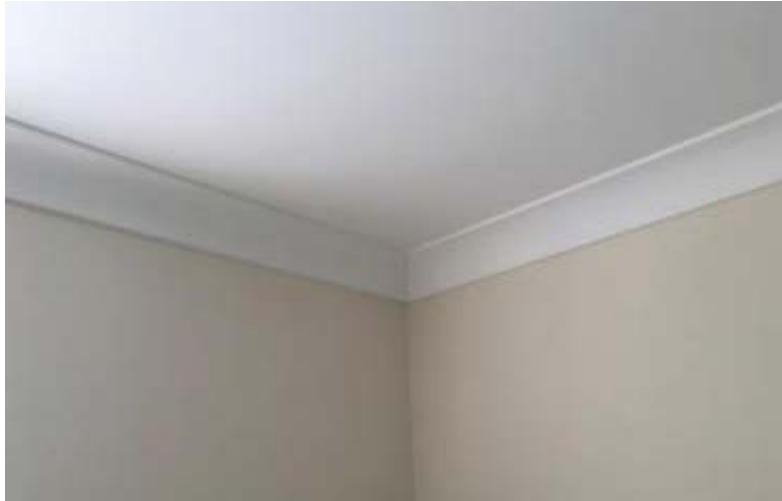
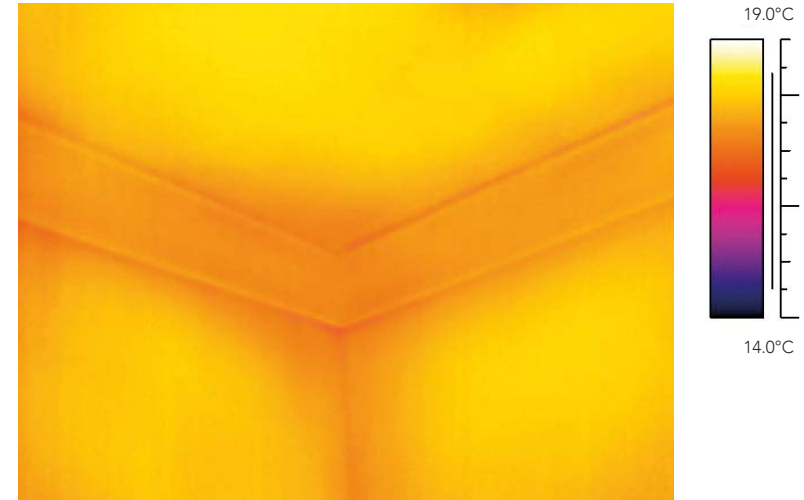
Thermographic image 17

Thermographic image 17: Good construction

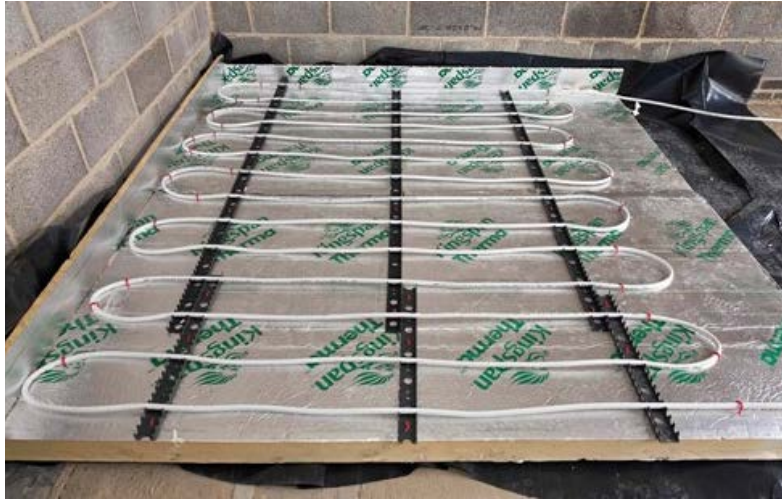
Thermographic image 21

Thermographic image 21: Good construction

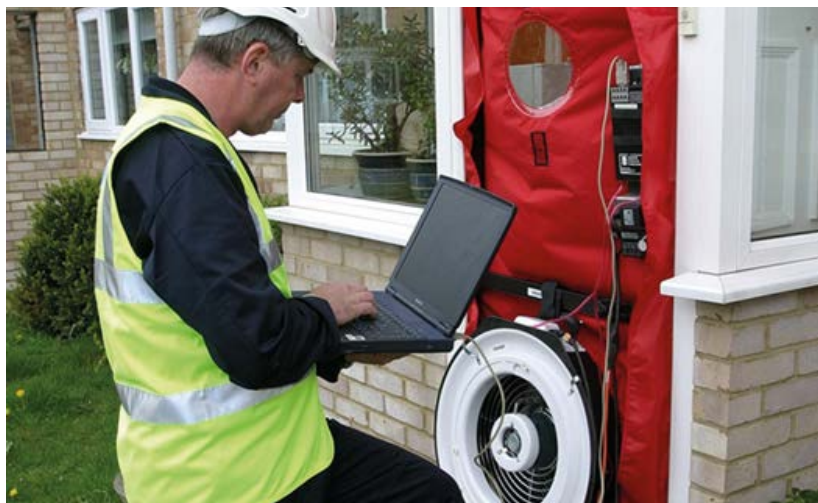
An air tightness test being carried out using a blower door kit

Thermal imaging can be used in conjunction with airtightness testing to help identify paths that would cause uncomfortable draughts or give rise to unwanted heat loss. The air tightness test is carried out at the same time as the thermographic survey is undertaken inside the home.
