# Thermal imaging report guide

How to interpret the results of a thermal imaging survey

Guide

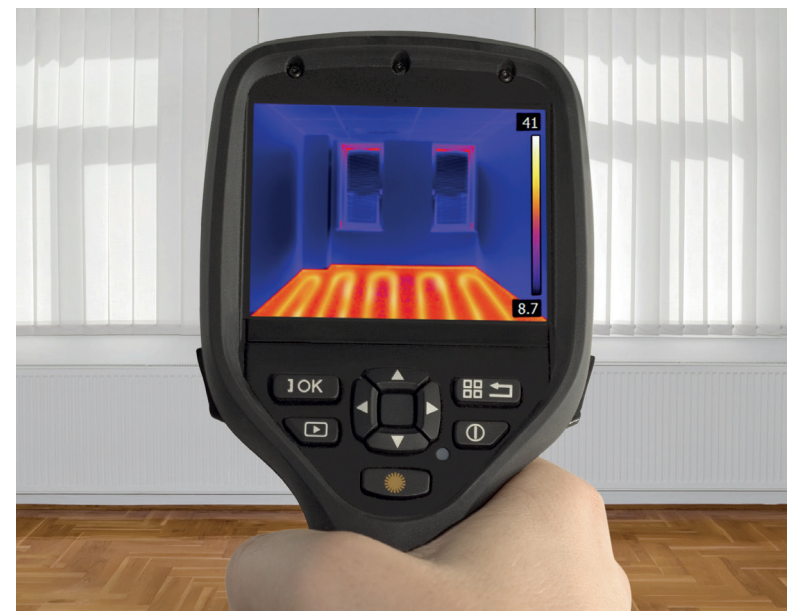
A thermal imaging camera showing underfloor heating pipe layout

Some new homes are now fitted with underfloor heating, the performance of which is determined by the even installation of heating pipework loops in the floor. Thermal imaging may also be used to determine whether these loops have been installed satisfactorily, in accordance with the design layout.

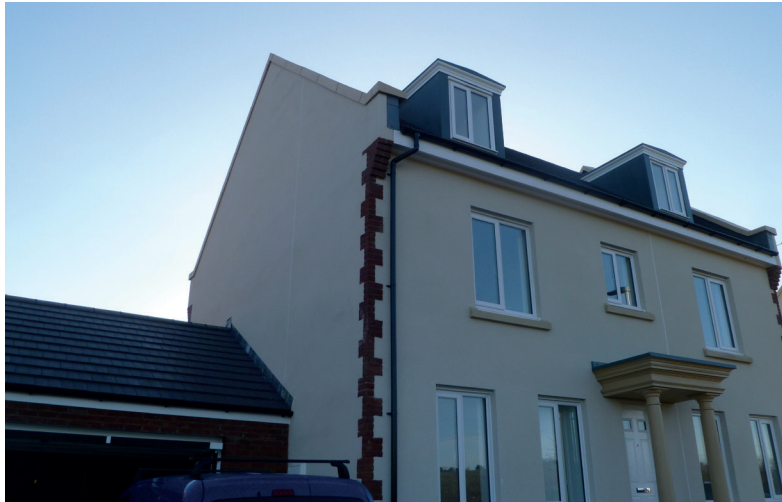
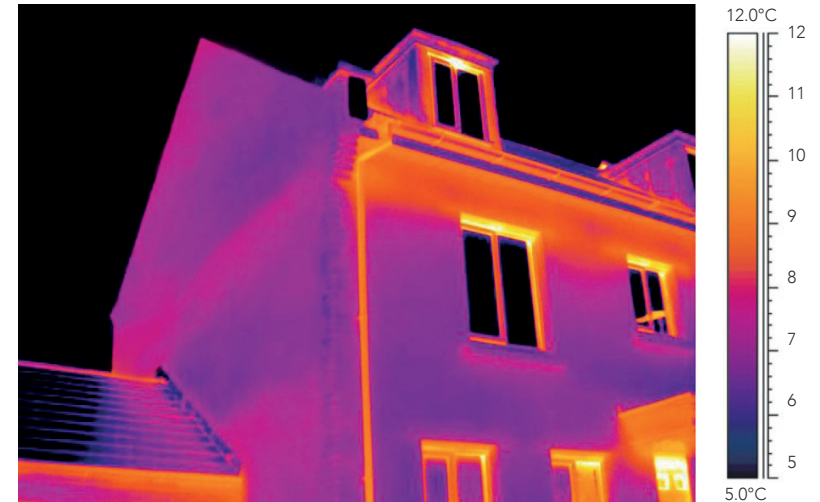
Thermographic image 1

### Thermographic image 1: Good construction

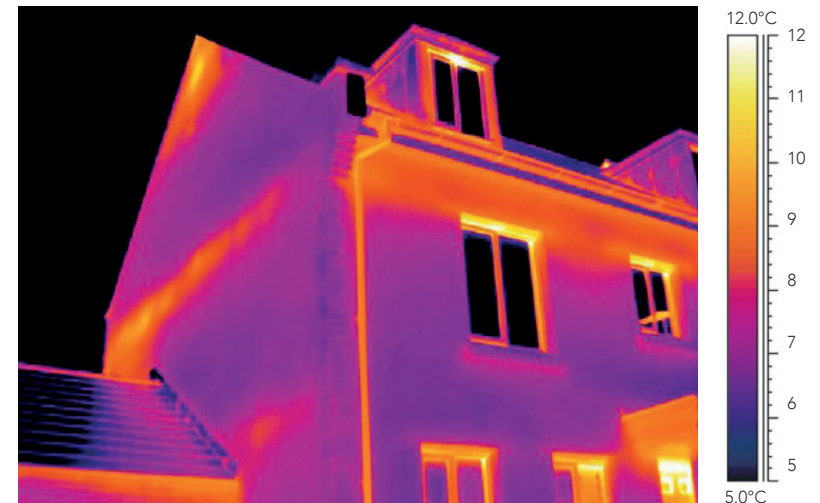
Thermographic image 2

### Thermographic image 2: Potential fault

The brighter yellow areas at the wall apex and in line with first and second floor joists indicate a higher surface temperature in these places, suggesting higher local heat loss. This may be due to inconsistency in the installation of the insulation batts with some areas of the cavity having gaps between the batts or a build-up of mortar debris.

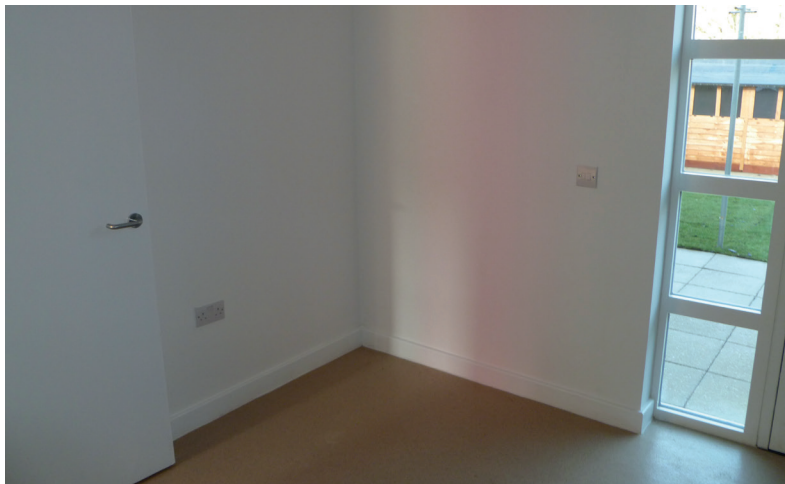
Thermographic image 5

#### Thermographic image 5: Good construction

It is normal for thermographic imaging to detect slightly lower temperatures at external corners of walls, both horizontal and vertical; this is caused by the slightly higher level of heat loss expected in these locations and is not a sign of a problem.

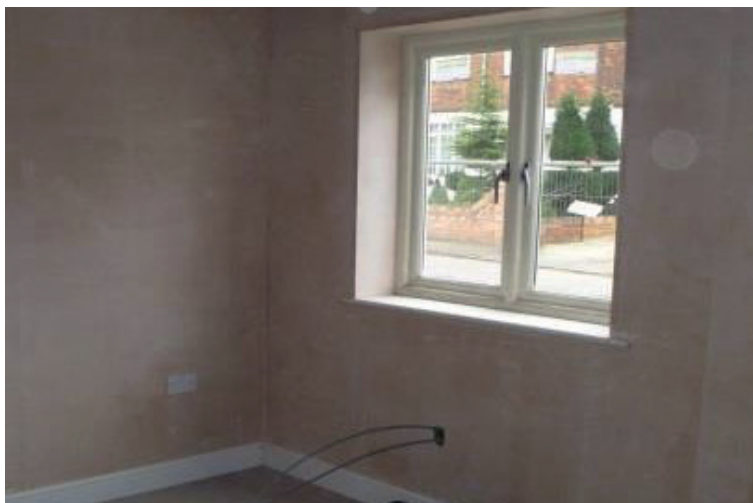
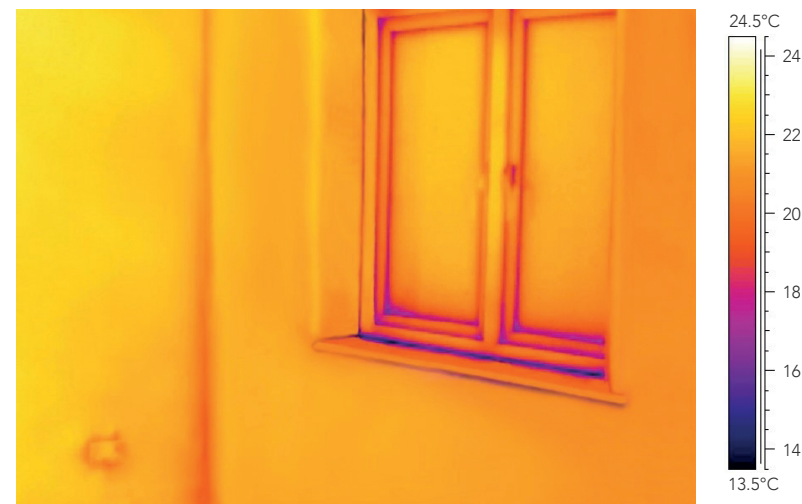
Thermographic image 9

### Thermographic image 9: Good construction

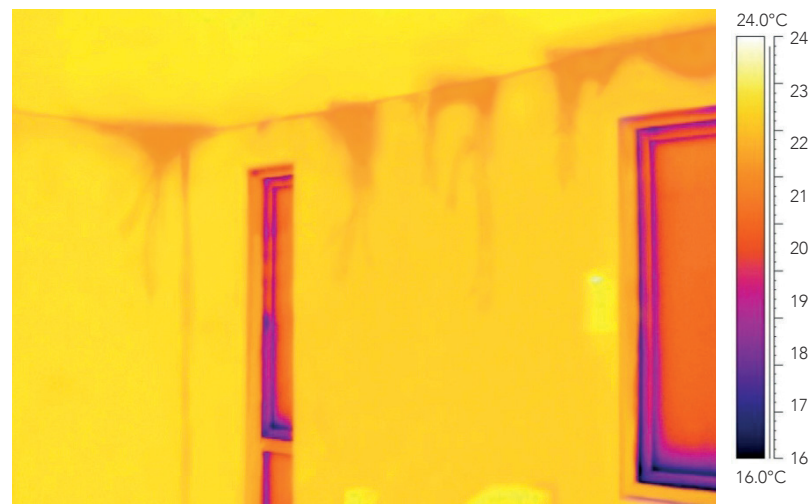
Thermographic image 11

### Thermographic image 11: Good construction

It is normal to detect slightly lower temperatures at external corners of walls, both horizontal and vertical; this is caused by slightly higher level of heat loss expected in these locations and is not a sign of a problem.

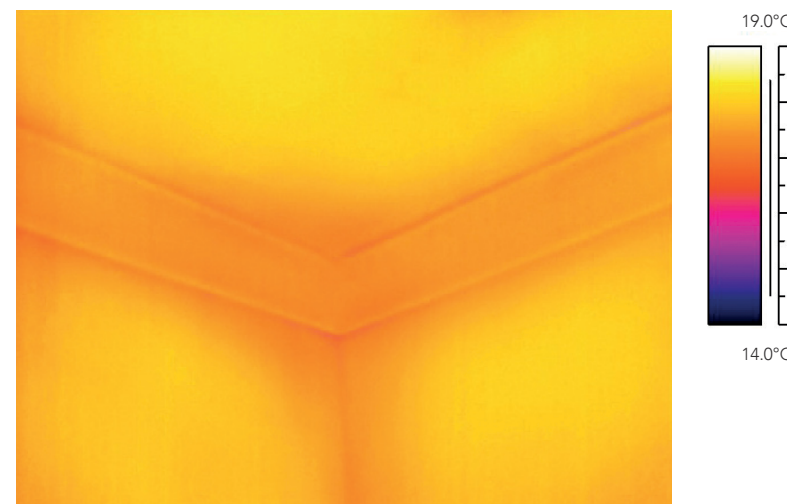
Thermographic image 17

### Thermographic image 17: Good construction

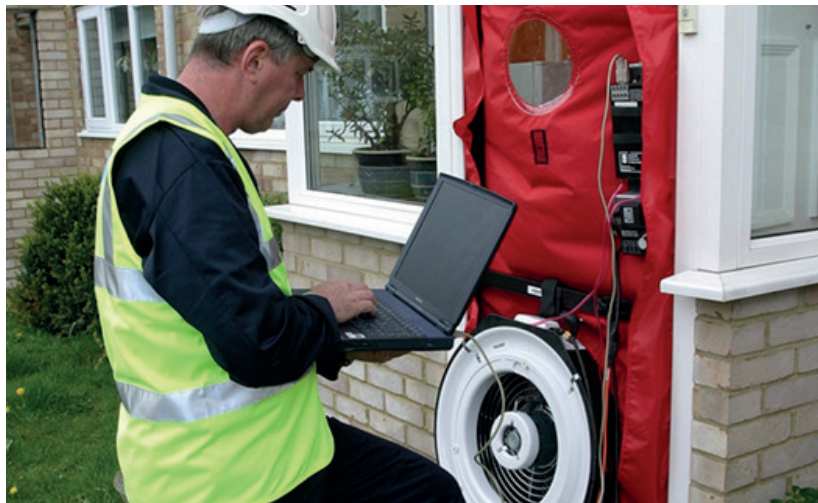
An air tightness test being carried out using a blower door kit

Thermal imaging can be used in conjunction with airtightness testing to help identify paths that would cause uncomfortable draughts or give rise to unwanted heat loss. The air tightness test is carried out at the same time as the thermographic survey is undertaken inside the home.
