# Fire performance of new residential buildings

© NHBC Foundation  
**NF36**  
Published by IHS BRE Press on behalf of the NHBC Foundation  
November 2011  
ISBN 978-1-84806-221-4

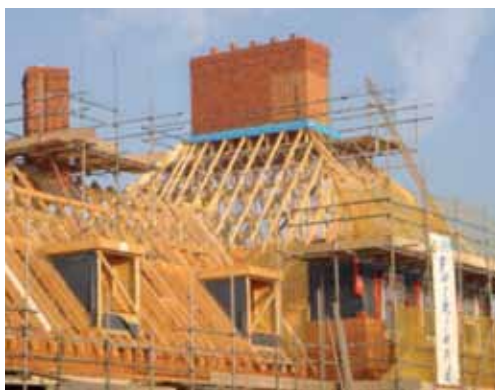
**Figure 1** 'Mock' chimney breast on a timber frame building (photo courtesy of London Fire Brigade)

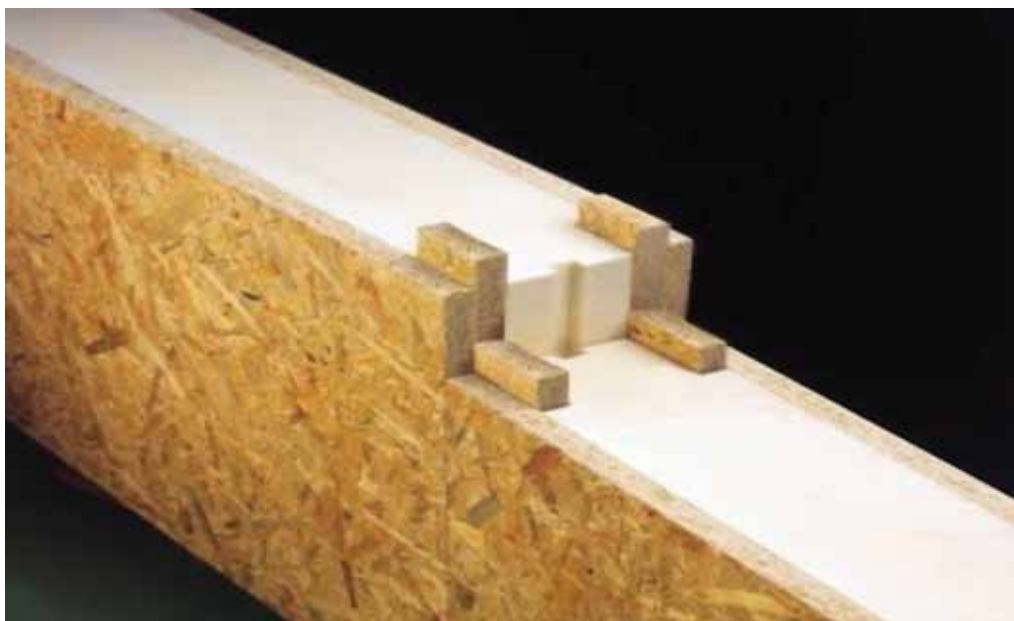
**Figure 3** Structural insulated panel showing oriented strand board (OSB) skins and insulated core (photo courtesy UK SIP Association)

Structural insulated panels (SIPs) are formed from the lamination of two structural grade boards separated by a polymer foam insulation core. These members are then used to form a building's primary structure. Typically, SIPs are used as compression members in walls, however, examples exist where SIPs are adopted as either roof, or occasionally floor, members. More information on the background to SIP technology including generic information on thermal insulation and structural performance may be found in BRE IP 13/04<sup>[12]</sup>. An example of a SIP wall panel is shown in Figure 3.

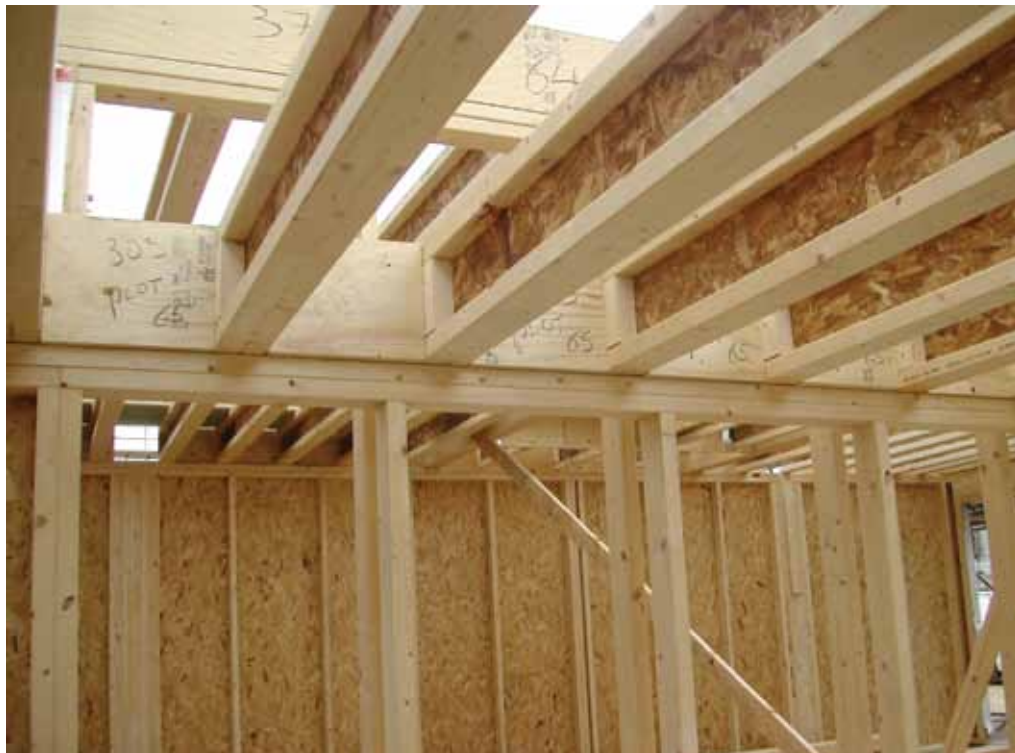
**Figure 4** Engineered floor joists (photo courtesy of UK SIP Association)

Solid timber floor joists are increasingly being replaced by engineered products such as timber 'I' beams and steel web joists which are lighter and stiffer than solid timber. These systems find widespread use across a range of construction systems including traditional forms of construction. Deep joists up to 12 m long can be produced allowing much larger distances to be spanned without the need for intermediate structural support. Examples of engineered floor joists are illustrated in Figure 4.

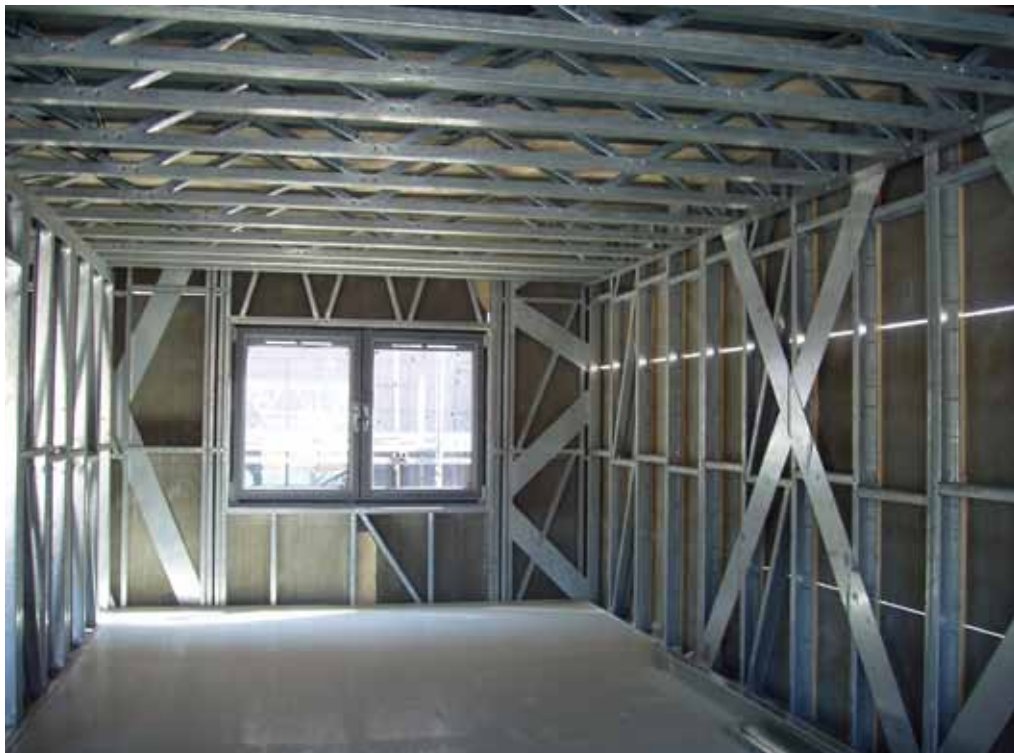
**Figure 5** Light steel frame showing floor cassette and wall frames

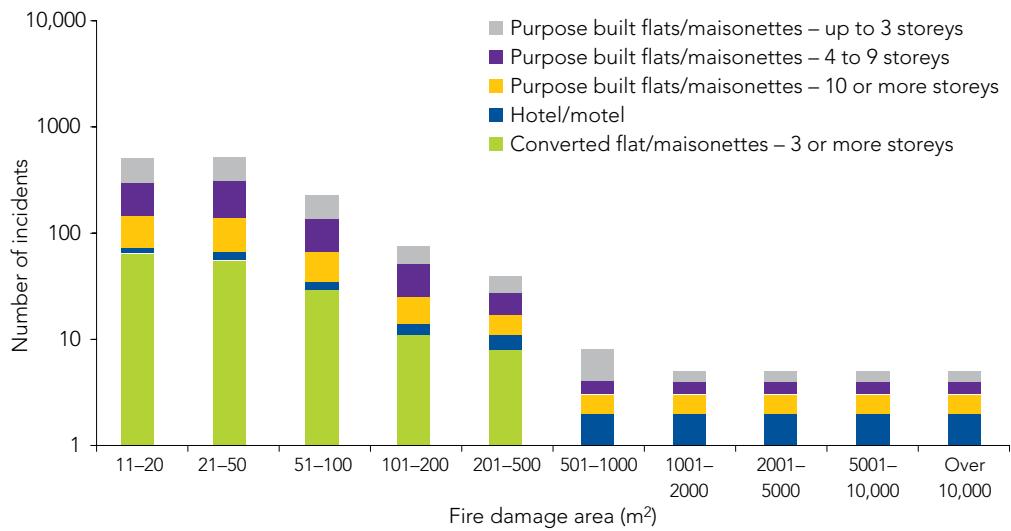
**Figure 6** Fire damage area by building use for multiple occupancy structures

The database was first interrogated to establish in which type of multiple occupancy structures the largest amount of 'damage' was observed (measured in m<sup>2</sup>). The information is summarised in Figure 6. The data set was limited to residential or residential type (ie hotels and motels) multi-storey buildings. Generally, it can be seen that most damage in such buildings is relatively small. However, where there is a large amount of damage, such events are more apparent in hotels than residential apartment buildings.

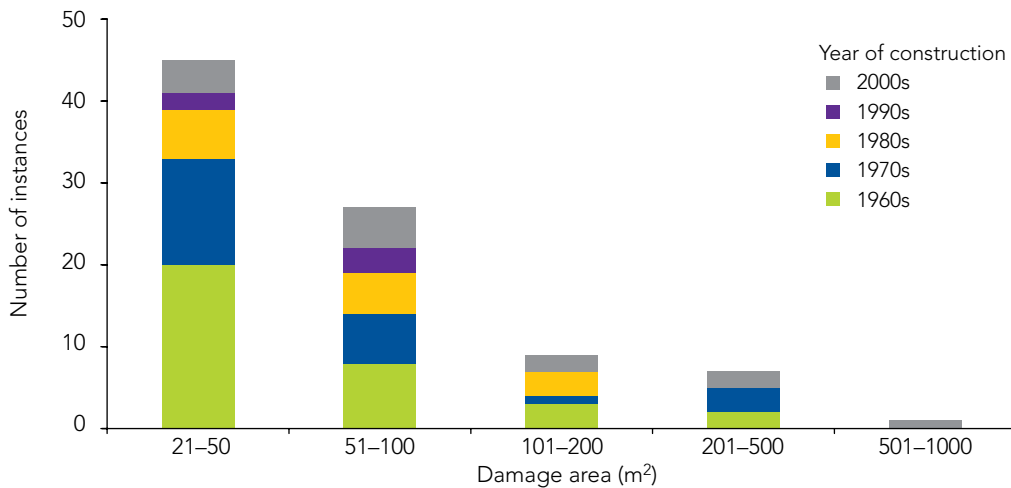
**Figure 7** Approximate year of construction versus fire damaged area for occupied flats and maisonettes ranging from four to nine storeys in height

If the search is focused upon occupied apartment buildings ranging from four to nine storeys in height, which was deemed to be the most likely instance where modern forms of construction may be adopted, then the amount of damage suffered due to fire can be correlated with the year in which it was constructed. This is shown in Figure 7.

The trend is a little inconclusive and appears to indicate that, although the largest volume of damage occurred in a building constructed after the year 2000, buildings constructed circa 1960 to 1970 are equally as susceptible to high levels of damage as modern buildings. This is, however, based on a relatively small sample size. Similarly, if the extent of fire spread is focused upon rather than the 'extent of damage', the results are shown in Figure 8.

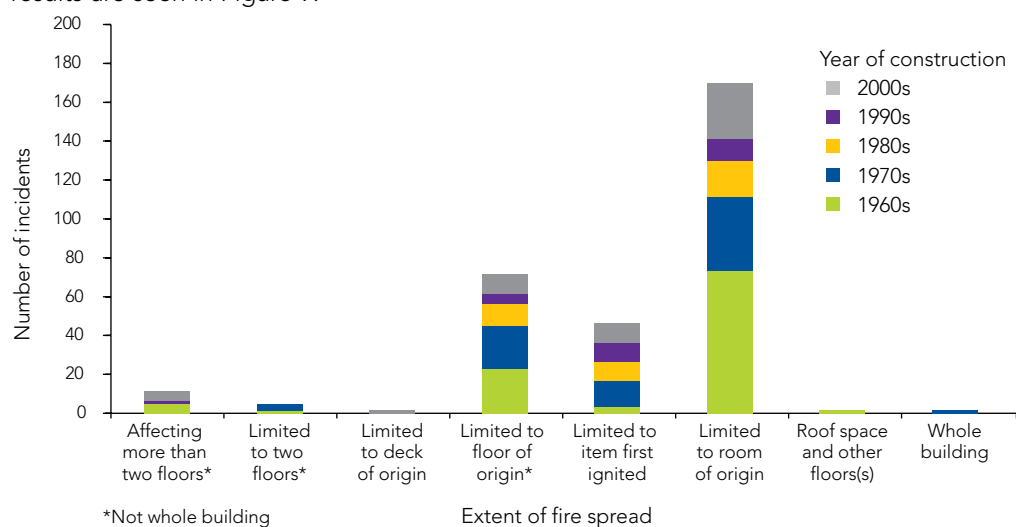
**Figure 8** Extent of fire spread versus year of construction for occupied flats and maisonettes ranging from four to nine storeys in height

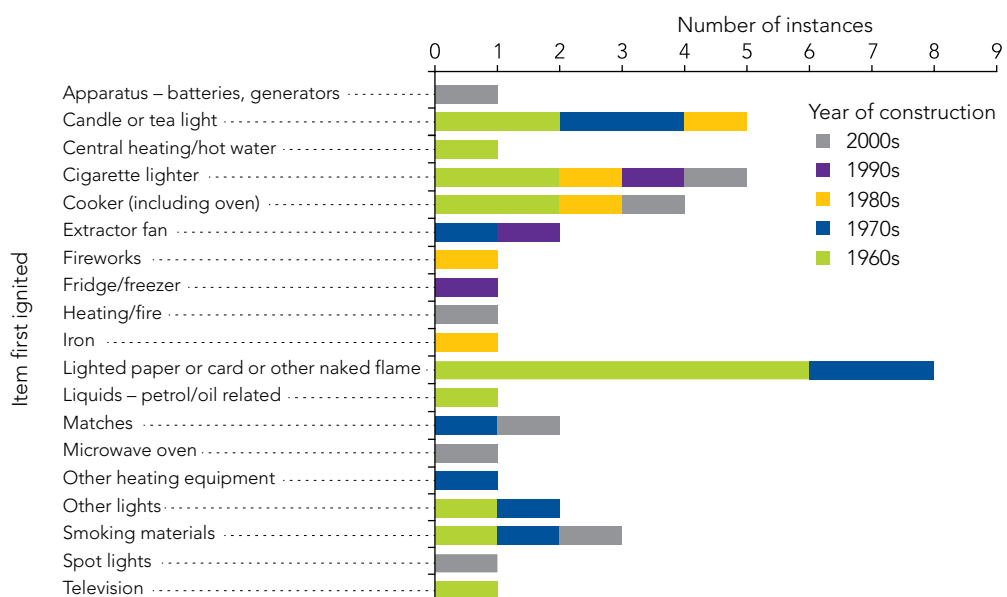
**Figure 9** Item first ignited versus year of construction, for occupied flats four to nine storeys in height, where the compartment of origin was breached

One of the many criticisms levelled at modern highly insulated buildings is that they suffer disproportionate damage in fires relative to more traditional construction. This refers to the concept that a very small fire may lead to the level of damage corresponding to that of a much larger severe fire. Supporting this concept with statistical evidence is difficult, however, if year of construction is plotted versus item of first ignition, for fires that have breached the compartment of origin in occupied four to nine storey flats, the results are seen in Figure 9.

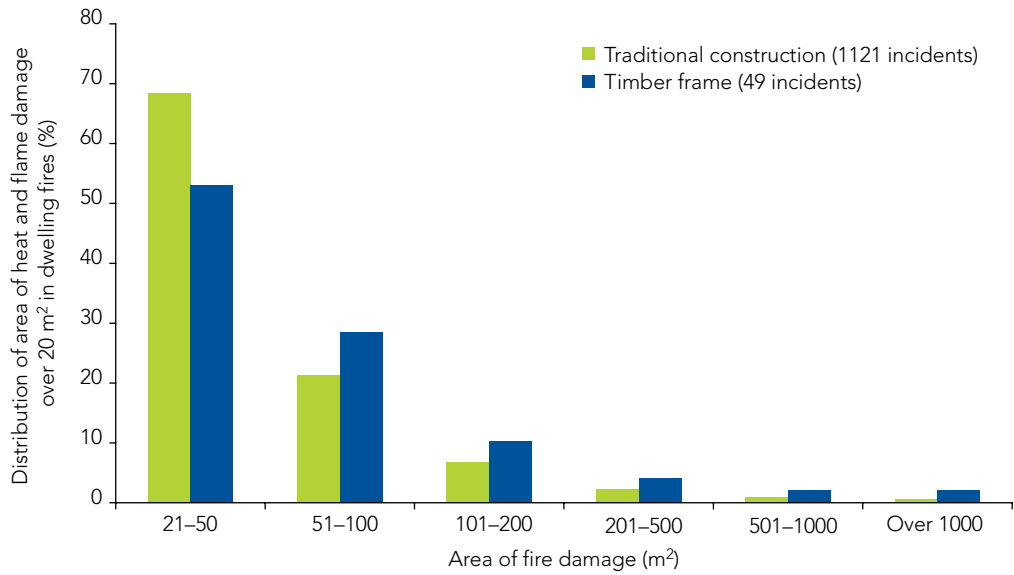
**Figure 13** Distribution of area of heat and flame damage over 20 m<sup>2</sup> in dwelling fires<sup>[20]</sup>

However, the differences are not particularly significant and further data are required. Attempts to relate information from fire incidents to specific forms of construction will, once sufficient data have been collated, enable informed decisions to be made. At present, the data are limited and the contextual information with regard to relative market share is missing. It is therefore very difficult to draw any firm conclusions with regard to the relationship between fire damage and modern forms of construction.

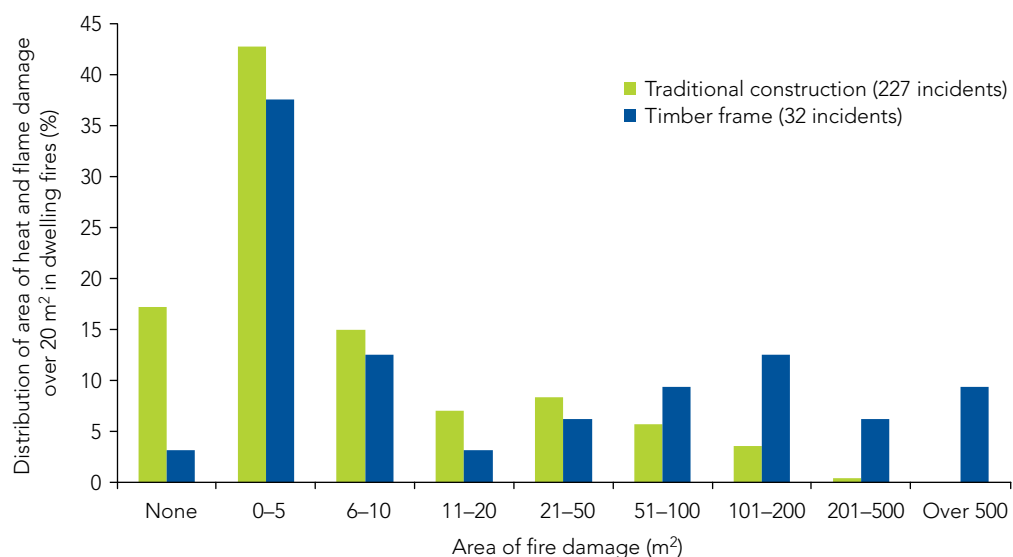
**Figure 16** Distribution of area of heat and flame damage for construction site fires<sup>[20]</sup>

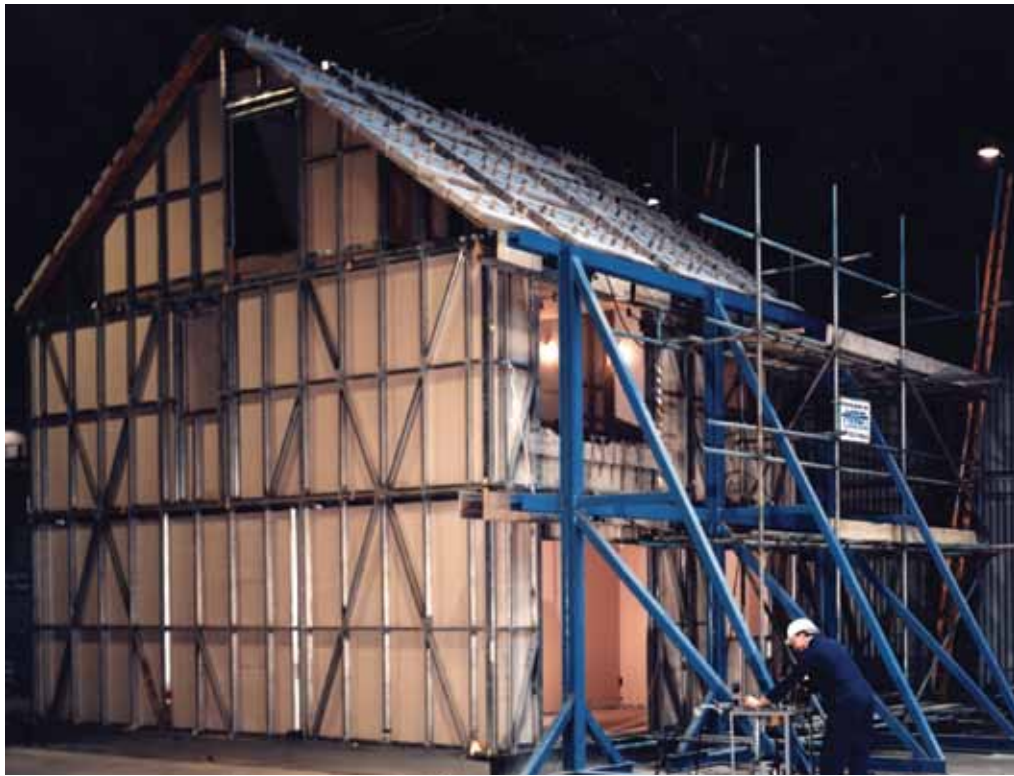
**Figure 18** Steel framed house used to demonstrate robustness

In terms of MMC, work undertaken by the Steel Construction Institute<sup>[51]</sup> (Figure 18) and BRE<sup>[38]</sup> (Figure 19) in conjunction with the UK timber frame industry have shown that typical examples of light gauge steel and timber frame construction provide high levels of robustness in relation to scenarios where key elements have been removed.

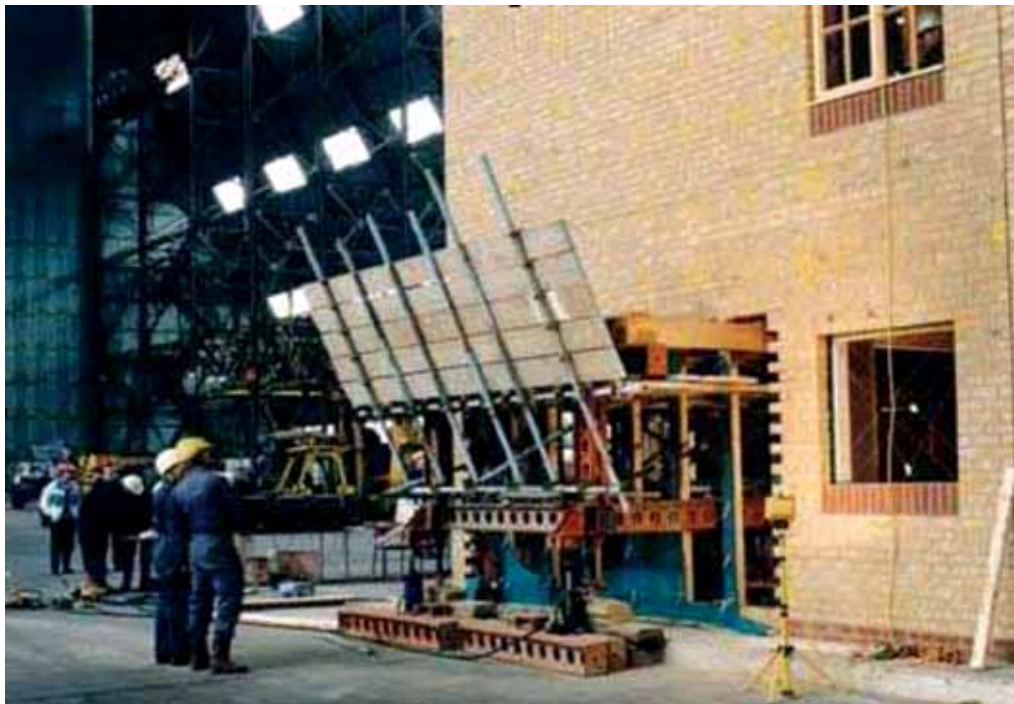
**Figure 19** Disproportionate collapse test on TF2000 timber frame building

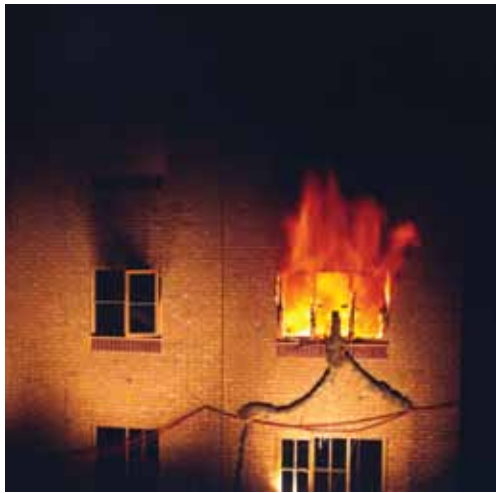
**Figure 20** Compartment fire test on 2nd floor of the TF2000 building

The risk of unseen fire spread in association with combustible cavities was brought into sharp focus following the compartment fire test on the TF2000 building at Cardington. After suppression of a fire test within one of the dwellings on the second floor of the building, a seat of smouldering combustion remained in the corner of the living area. Over a number of hours, this small ignition source burnt through the OSB panelling and entered the cavity between the timber frame and the external masonry cladding. This particular area was open to the elements at the bottom of the cavity due to a previous structural test to investigate disproportionate collapse (see Figure 19). Once the smouldering timber came into contact with the ventilated cavity, the fire quickly developed with initially the OSB sheathing board providing the main source of fuel. The horizontal barriers at compartment floor level proved ineffective in preventing vertical fire spread. Over the course of the evening, the fire spread from the second to the fifth floor. The initial fire test before the cavity fire incident is illustrated in Figure 20. Figure 21 shows the damage to the external wall at a level above the initial fire compartment and clearly shows that, not just the sheathing board but the entire loadbearing stud wall and sections of the loadbearing ring beam have been consumed by the fire. Some minor clearing away of debris and removal of existing boards had taken place. The extent of vertical fire spread is illustrated in Figure 22 showing the front elevation of the TF2000 building after the cavity fire event.

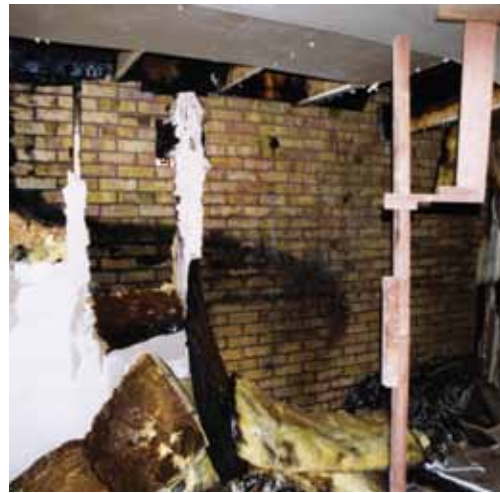
**Figure 21** Loadbearing wall completely consumed by the cavity fire (3rd floor) of the TF2000 building

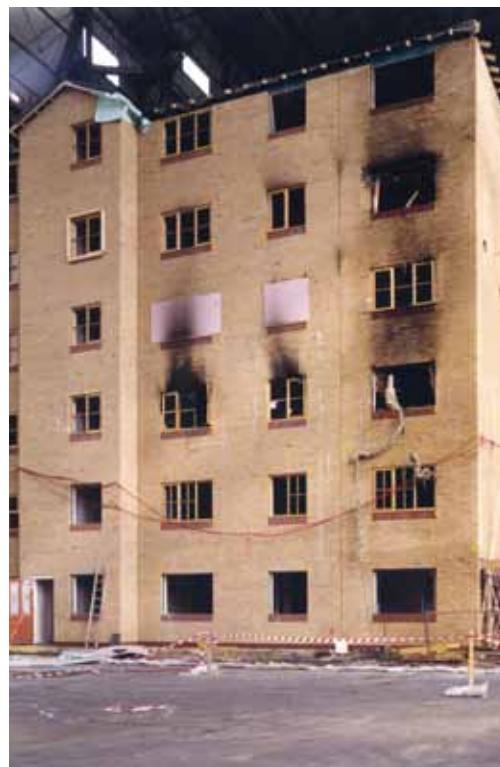
**Figure 22** Front elevation of TF2000 building showing extent of vertical fire spread

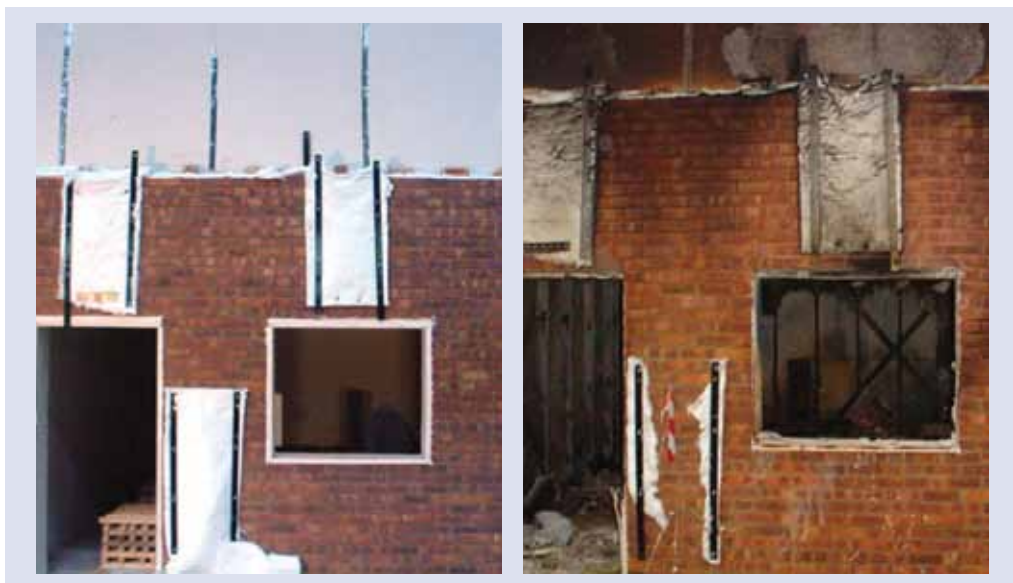
**Figure 23** Light steel frame fire test (before and after)

The first test (Figure 23) had to be terminated due to fire breaking through the end wall before any significant damage had occurred to the separating floor or wall. In the test, there was no external gable wall present. In a realistic scenario, the observed behaviour would have led to the fire breaking into the cavity between the structural frame and the brickwork forming the gable end. The performance of the cavity barrier between the frame and the brickwork would then become critical. However, once the plasterboard has fallen away, the fire is then in contact with the thermal sheathing, in this case a rigid polystyrene board. As the board melts, a new cavity is created between the structural frame and the moisture-resistant plasterboard. In this instance, there was no provision for fire stopping in this area. For multi-occupancy dwellings, it is recommended that the plasterboard specification to the external walls is at least equivalent to that used for the ceiling to the compartment floor and the party walls. Although all elements may meet the requirements of the Building Regulations, care should be taken to ensure that system performance is not compromised by failure of the weakest element. In this instance, the specification was for 60 minutes' fire resistance for the party wall, 60 minutes for the floor and 30 minutes for the external wall.

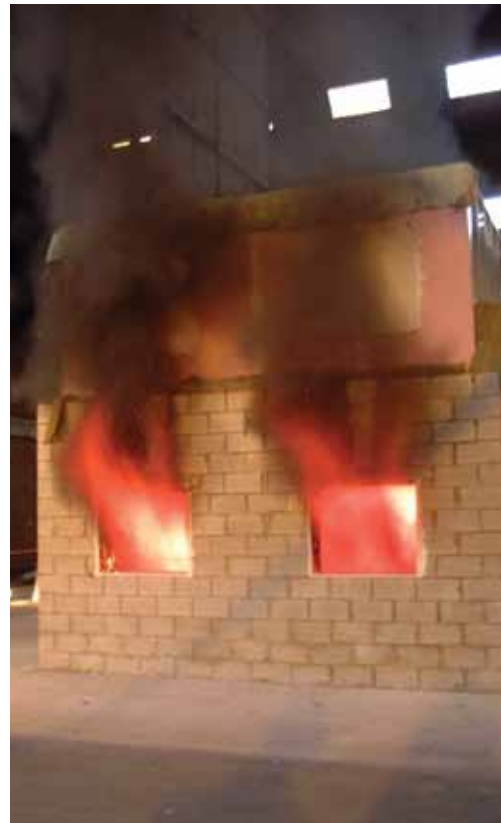
Figure 24 Fire test on light steel frame building

For the second test (Figure 24), the specification for the external wall was increased to 60 minutes resulting in a very different mode of failure. Once the plasterboard had fallen from the ceiling, the strength of the floor joists was reduced leading to significant vertical deflection. Ultimately, the dead weight of the floor system, together with the imposed load on the floor above, caused a partial collapse of the floor followed soon after by complete collapse. The boards on the walls were still intact at the time the floor collapsed. The boards were removed to assist staff in fighting the fire following collapse. In some cases, the screws fixing the floor joists to the top rail through Zed hangers had sheared off. Immediately before collapse of the floor, flames could be seen inside the cavity between the floor joists. This can only have been caused through ignition of combustible material used in the construction of the floor. It is likely that the OSB sheeting, resilient layer and polythene sheet all contributed to this localised fire development.

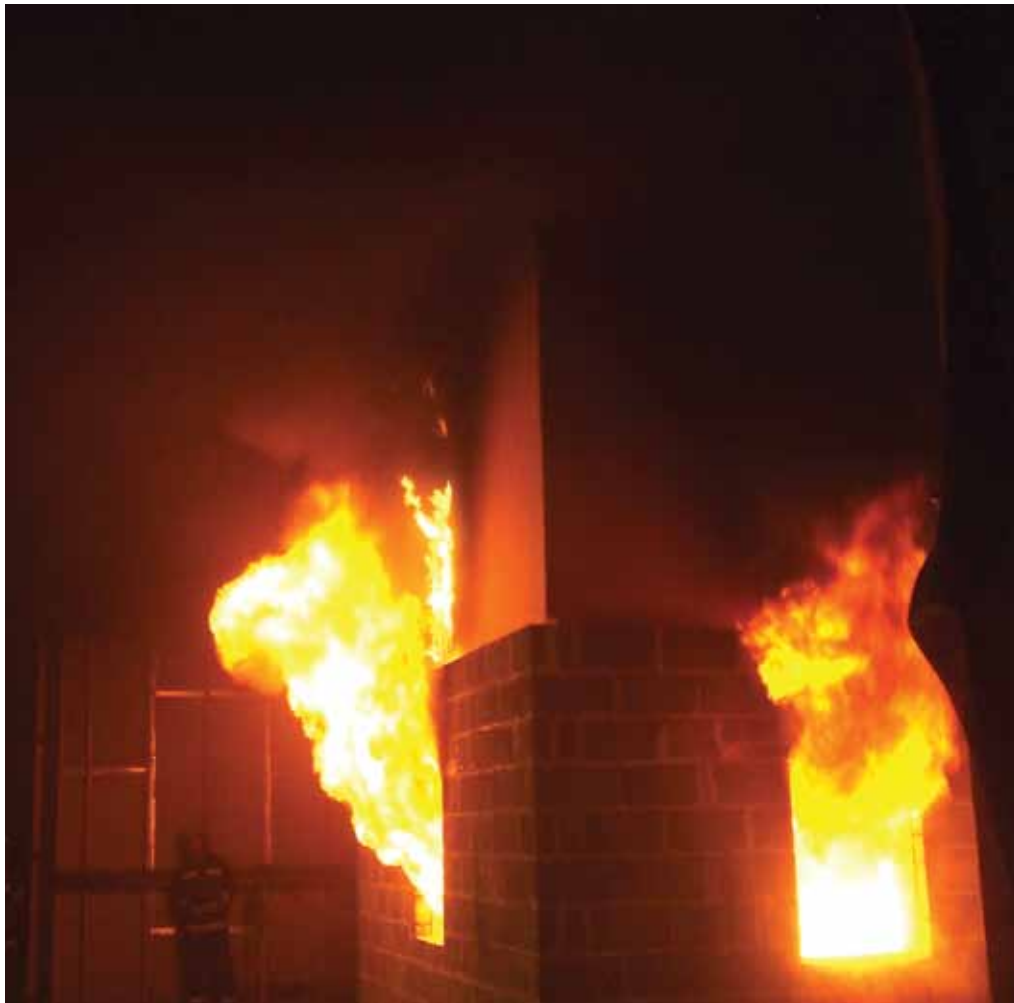
**Figure 25** Large-scale fire test programme

The 30 and 60 minute design solutions were effectively representing a two storey house and a multi-occupancy apartment dwelling, respectively. In all cases, the fire loading and ventilation conditions were the same with the fire designed to provide an equivalent severity to a 60 minute exposure in a standard fire test<sup>[23]</sup>. The results from the large-scale fire tests are summarised in Table 11. The scale of the fire testing is illustrated in Figure 25.

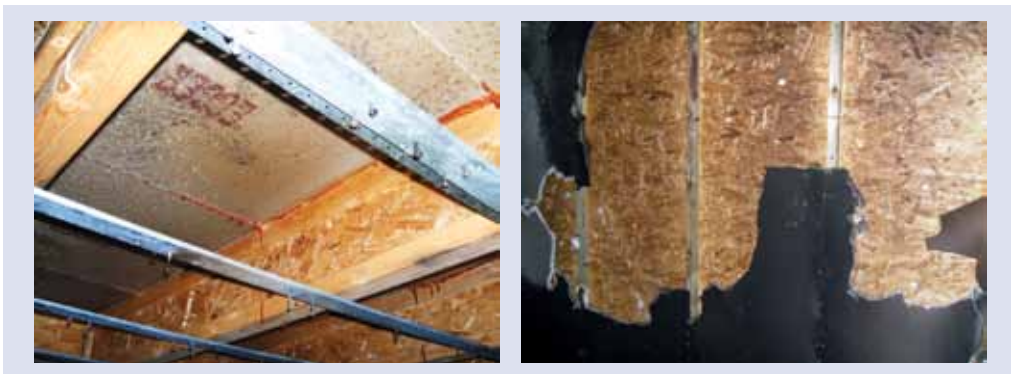
**Figure 26** Limited damage to floor joists and party wall. Test F1.

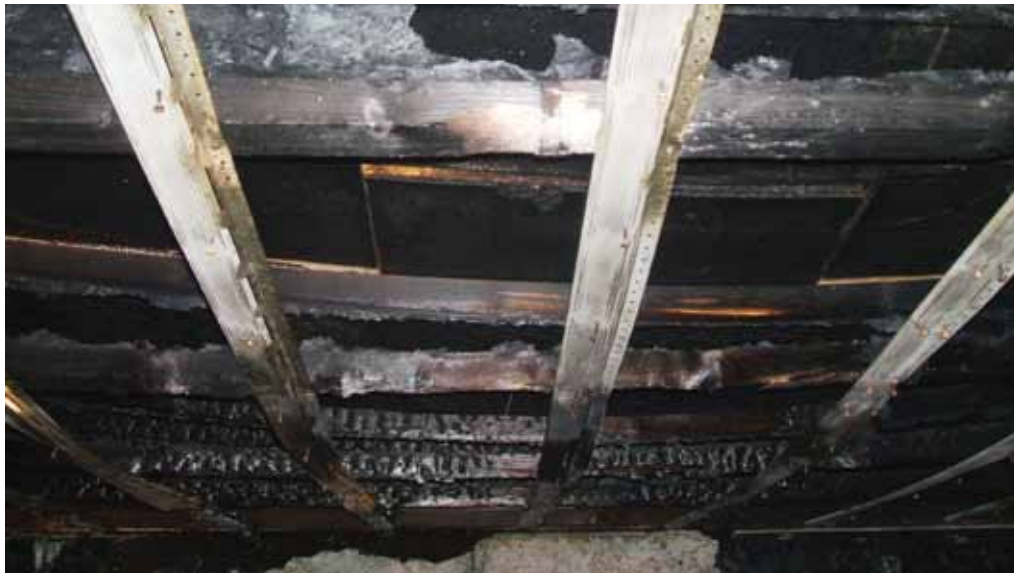
Figure 27 Damage to engineered floor joists. Test F2.

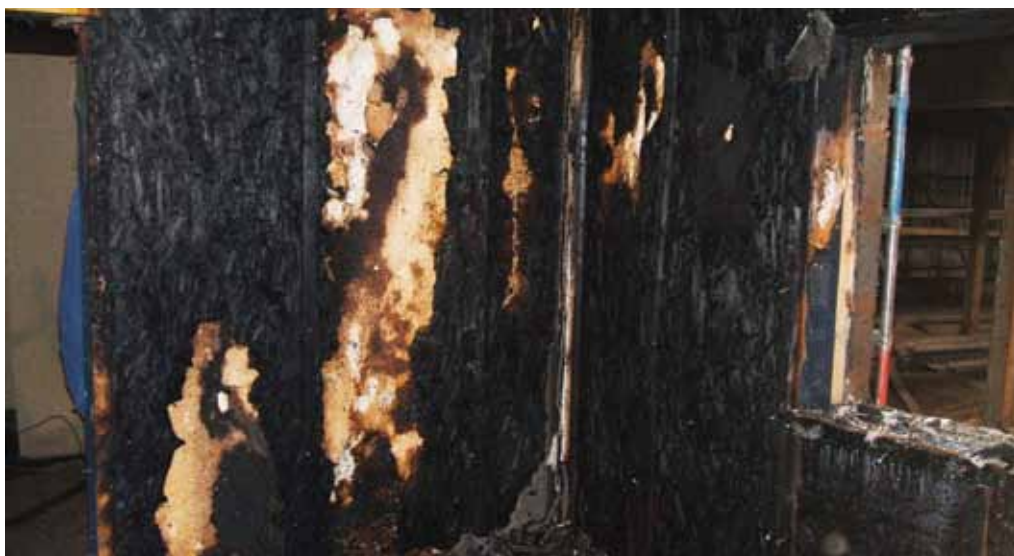
Figure 28 Damage to PUR wall panels. Test F3.

F3	Maximum atmosphere temperature 1071°C after 51 minutes. Test continued up to cooling phase. Peak temperatures in floor void approximately 200°C with a corresponding maximum deflection of approximately 15 mm. Core temperatures largely unaffected by the fire for the duration of the test but continued to rise in the cooling phase. Some time after the initial fire had been extinguished, localised combustion continued within the wall panels with the inner surface of the PUR involved. Although initially there was no evidence of any damage to the wall panels, the post-test damage was significant (Figure 28). The inclusion of electrical sockets did not influence the temperature of the panels.
F4	Maximum atmosphere temperature 1083°C after 49 minutes. Test terminated 50 minutes from ignition due to runaway deflection of the floor caused by combustion of the OSB web of the engineered floor joists once the integrity of the ceiling plasterboard had been compromised. Peak temperatures in the floor void 664°C with a corresponding maximum deflection of 120 mm. Although the temperature within the external wall panels continued to increase towards the end of the test, any combustion of the PUR insulation was quickly dealt with by the Fire and Rescue Service. Temperatures within the core of the party wall remained low throughout the test. The inclusion of electrical sockets did not influence the temperature of the panels.

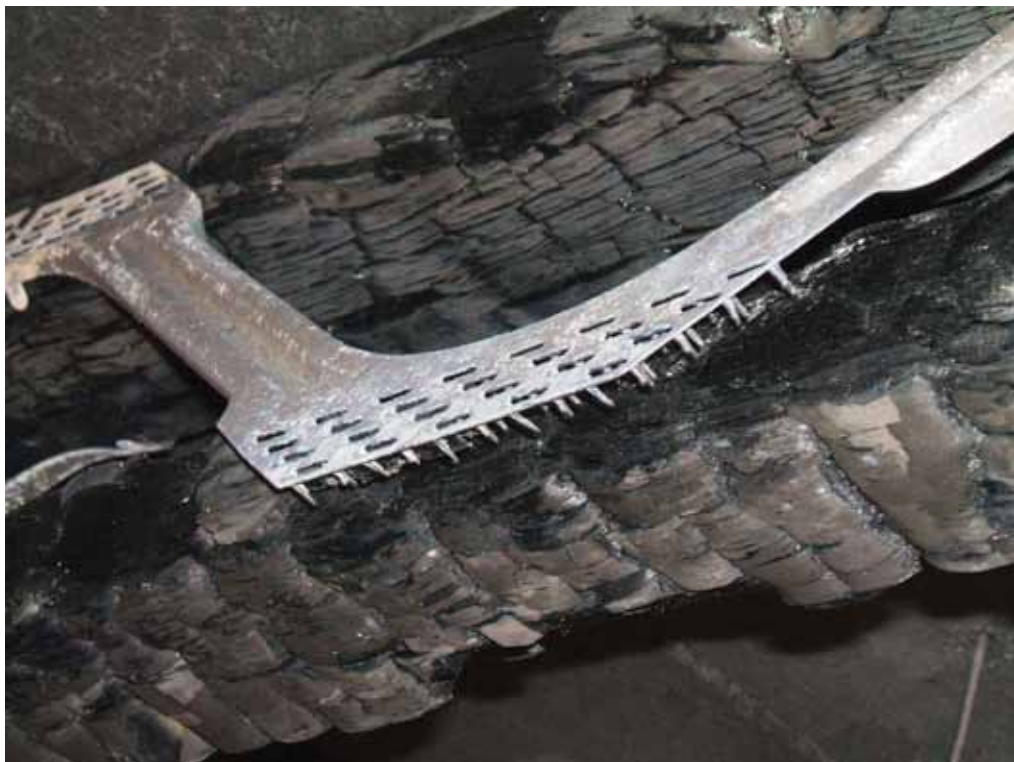
**Figure 30** Loss of fixity between steel web elements and lower timber chord

When exposed to fire directly, the behaviour of engineered truss joists, similar to the one tested, results in a more rapid, less ductile, mode of failure. The test showed that this type of floor system exhibits large deflections and continues to deflect at a high rate over a short period of time leading to a sudden failure of the floor system. In this case, the steel modules forming the web of the section were detached due to charring of the timber chords (Figure 30) which caused the connecting plate to lose its bond with the chord members.

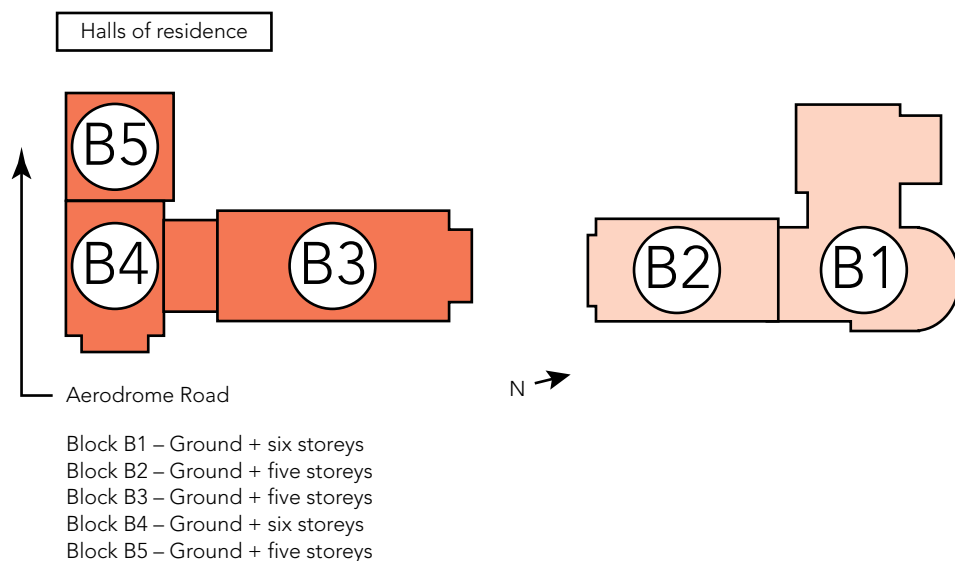
**Figure 31** Site plan for Beaufort Park development

A schematic of the site plan is shown in Figure 31 which illustrates the relationship between blocks B1 to B5. At the time of the fire, B1 was virtually complete and ready for hand over, B2 was partially completed with the rainscreen cladding (a combination of masonry and rendered cement particle board) under construction. Blocks B3 to B5 consisted of the bare timber frame only without any cladding or sheathing. Effectively, B3 to B5 formed one structure separated by a distance of some 18 m from the adjacent building housing blocks B1 and B2.

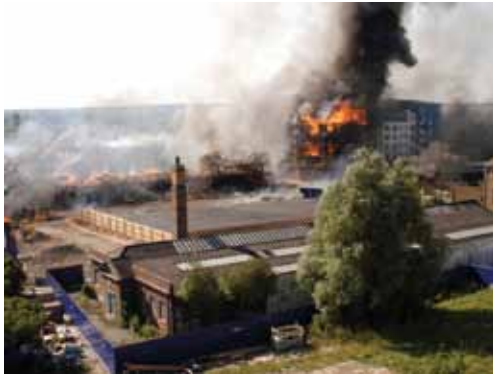
**Figure 32** B3 (east elevation) collapse and fire spread to B2 (reproduced by courtesy of the London Fire Brigade)

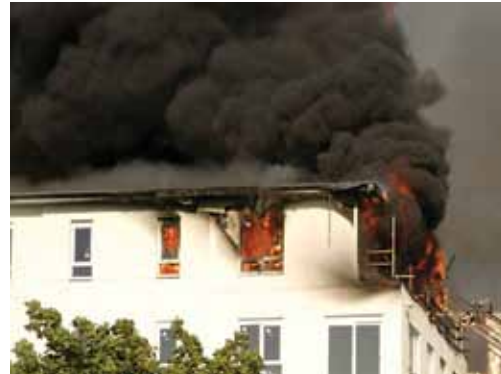
**Figure 33** Fire spread to block B2 (reproduced by courtesy of the London Fire Brigade)

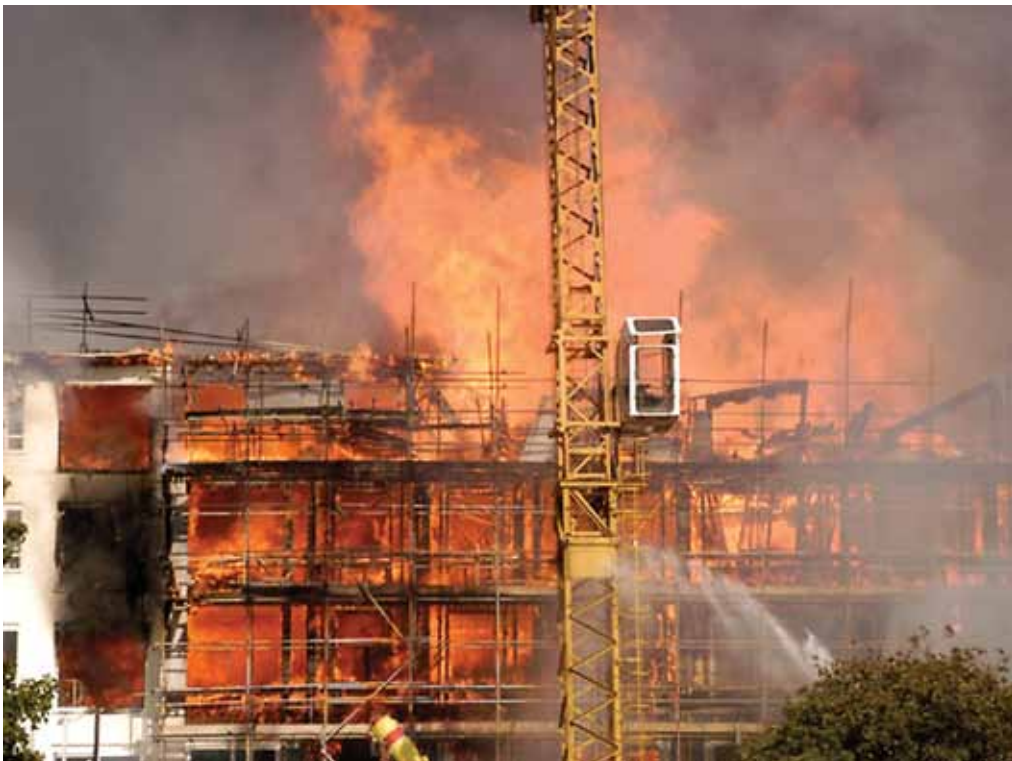
**Figure 34** Block B2 fully involved (reproduced by courtesy of the London Fire Brigade)

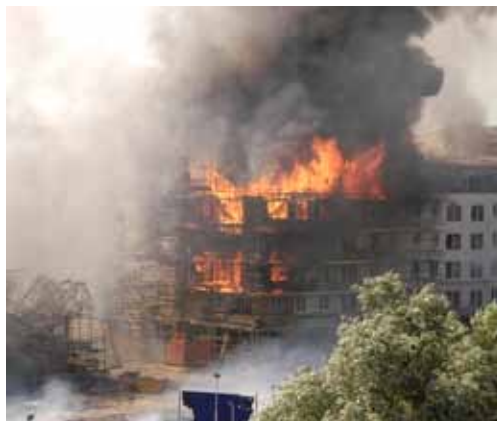
**Figure 36** Fully developed fire (reproduced by courtesy of the London Fire Brigade)

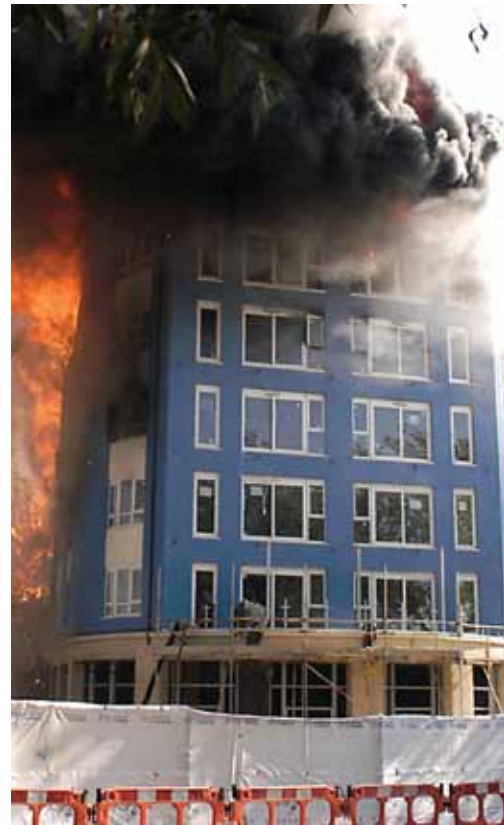
**Figure 35** Fire spread to block B1 (reproduced by courtesy of the London Fire Brigade)

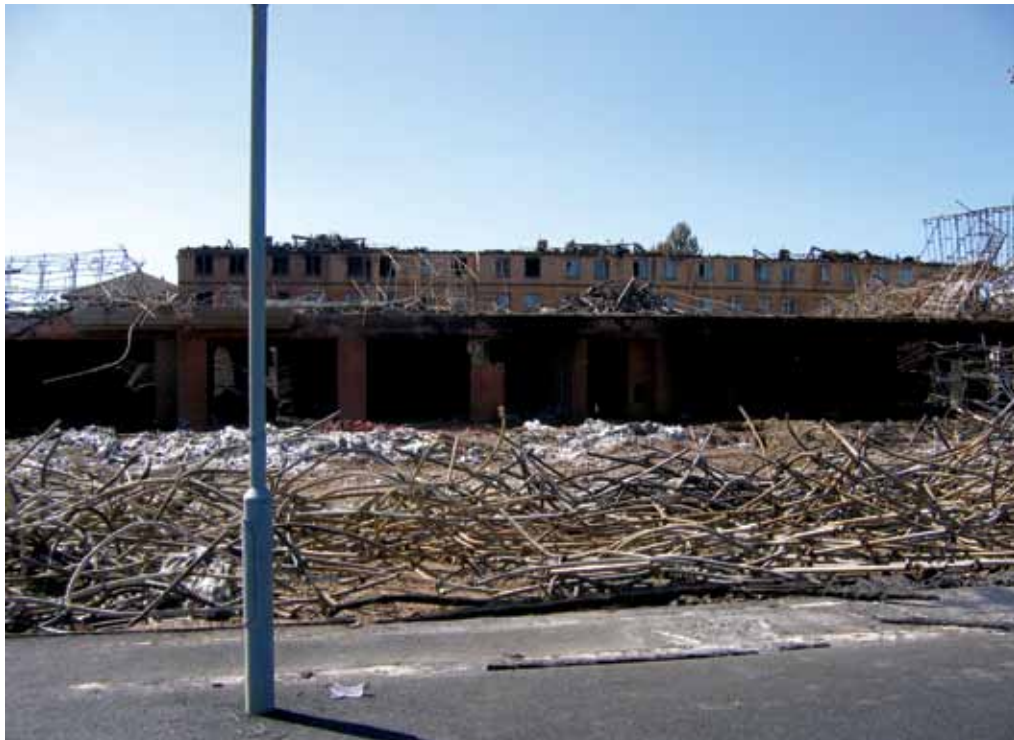
**Figure 37** Extent of damage to roof structure of student accommodation opposite blocks B4 and B3

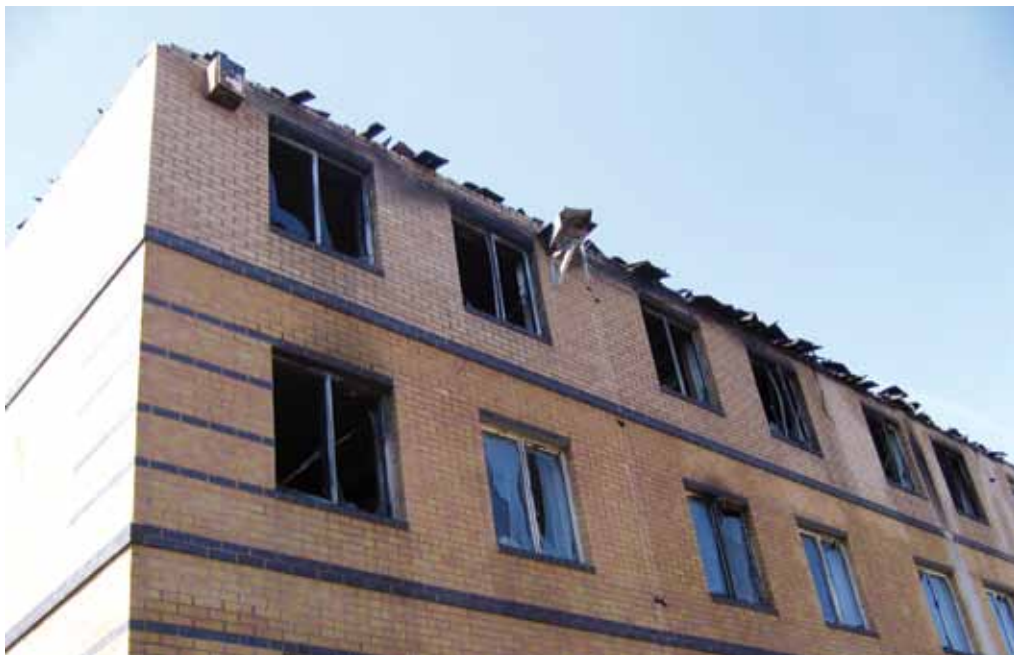
**Figure 38** Damage to eastern elevation of student accommodation
